REPAIRCERT NZ UPDATE

UPDATE No. 15 | 21/11/2022

Technical Support Group Gets the Ball Rolling!

Sectioning and Partial Replacement of Outer Panels

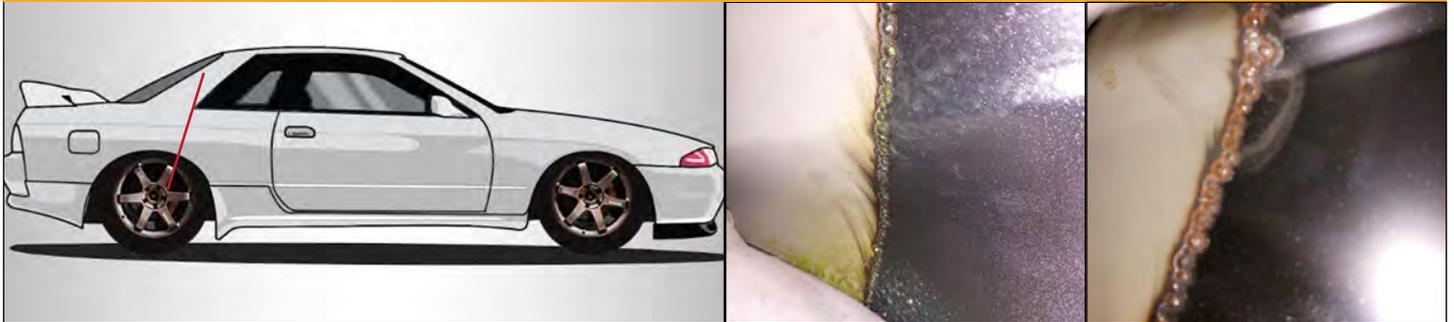
Case Study 1: Nissan Skyline Coupe

Image left: The front portion only of the outer rear quarter has been partially sectioned (cut and join location shown in RED). **Image middle and right:** Interior inspection of the welded joint(s).

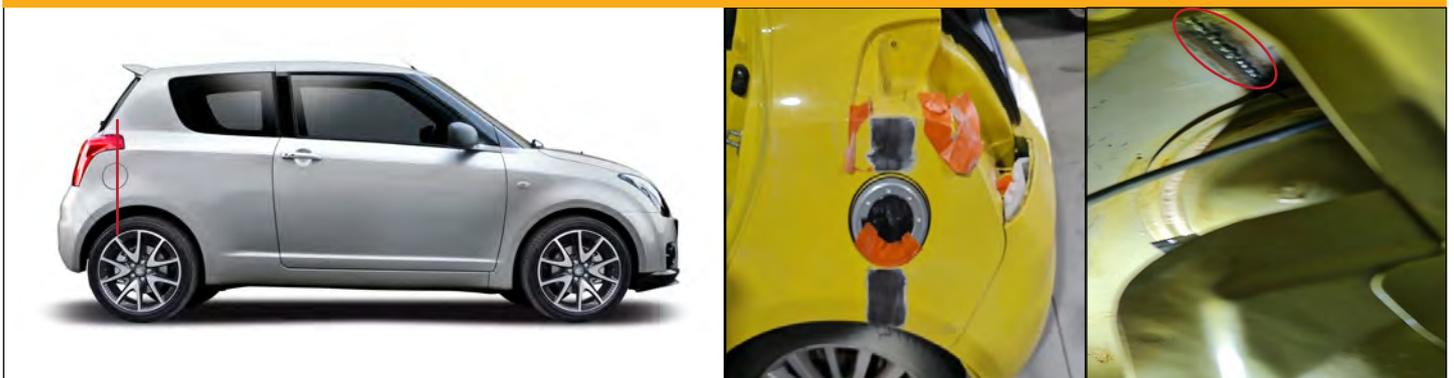
Case Study 2: Suzuki Swift

Image left: The rear portion only of the outer rear quarter has been partially sectioned through the middle of the fuel filler pocket (cut and join location shown in RED). **Image middle and right:** Exterior and Interior inspection of the welded joint(s).

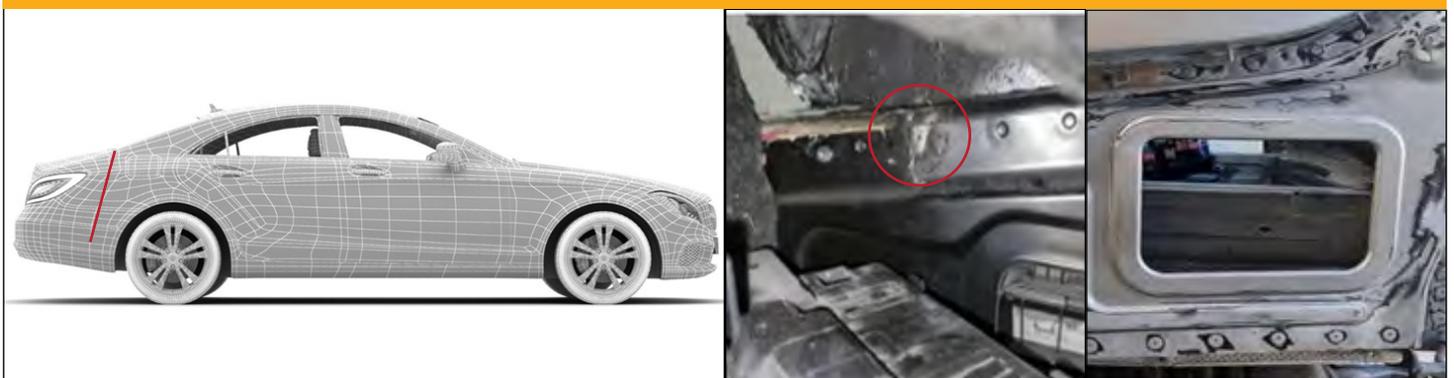
Case Study 3: Mercedes Benz S400

Image left: The rear portion only of the outer rear quarter panel has been partially sectioned rearward of the C pillar (cut and join location shown in RED). **Image middle:** Interior inspection of the welded joint(s). **Image right:** Exterior inspection of rivet-bonded areas (with coatings and sealers removed).
