Repairability of Outer Body Panels Are We Making the Right Decisions?

Supporting New Zealand's Repair Certification Industry

Purpose of this Technical Bulletin

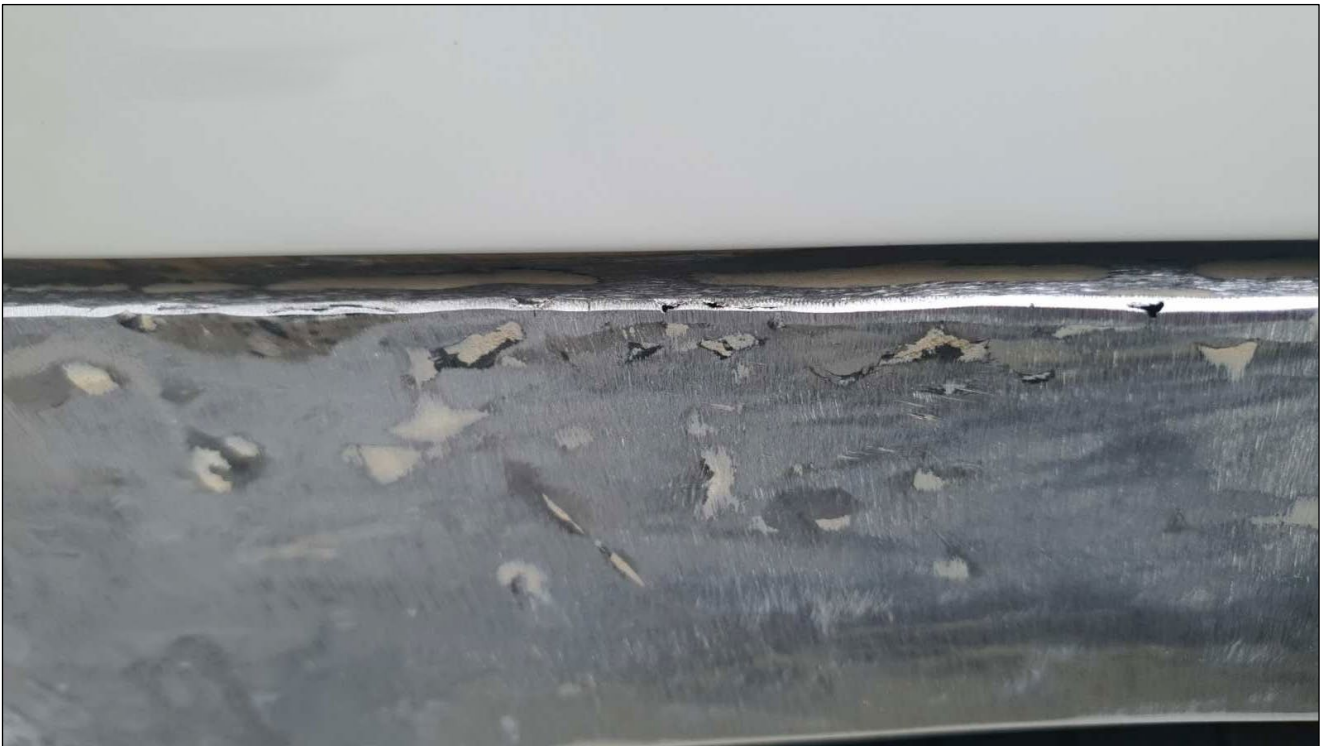
Image 1.

In Image 1, after the removal of body filler, it is obvious the base metal has been substantially thinned, with holes and perforations clearly visible. The extent of the damage determines that this panel should not be re-repaired, and replacement or sectioning is the appropriate 'repair' method (*see Image 1*).

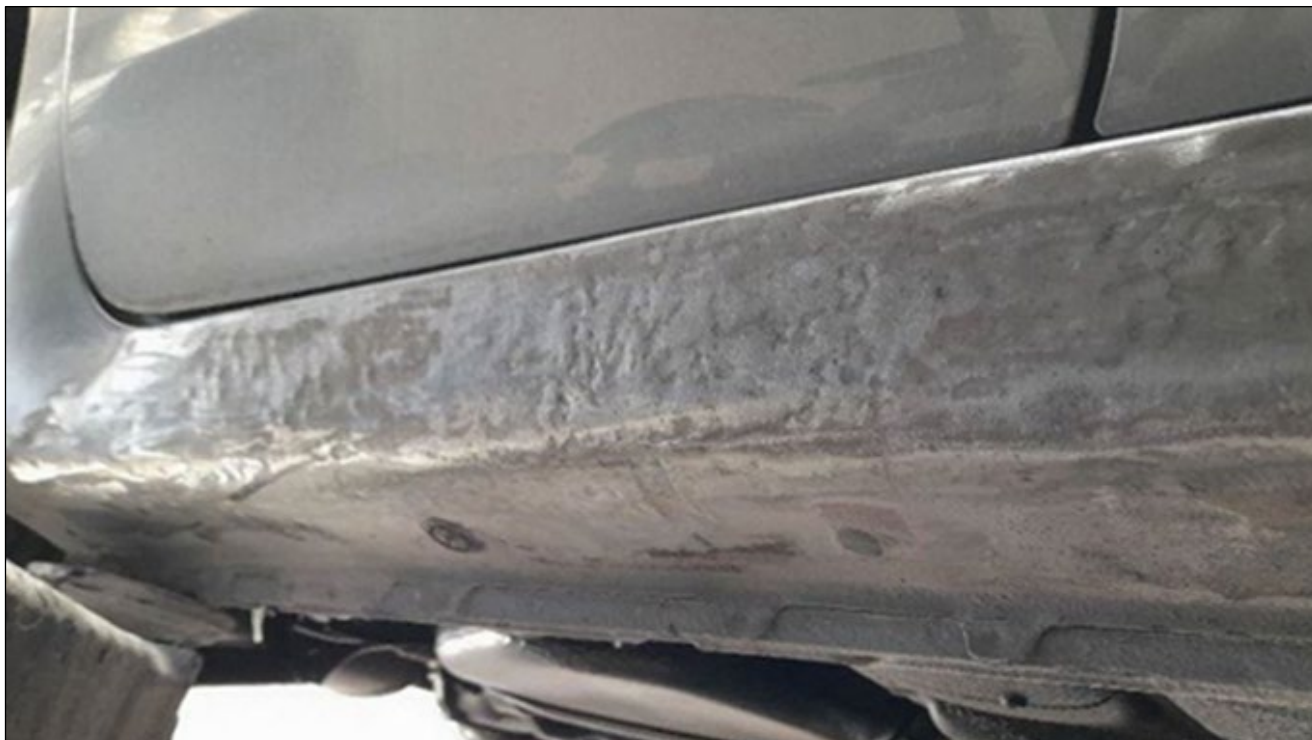
Image 2.

In Image 2, the steel has been over-stretched and work-hardened, and the original contours and shapes of the panel have not been restored. The extent of the damage determines that this panel should not be re-repaired, and replacement or sectioning is the appropriate 'repair' method (*see Image 2*).

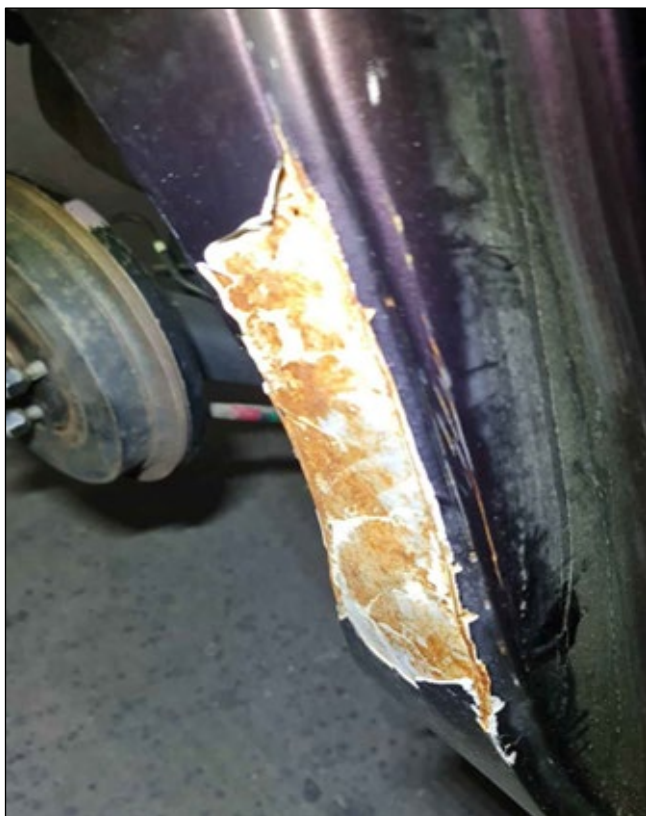
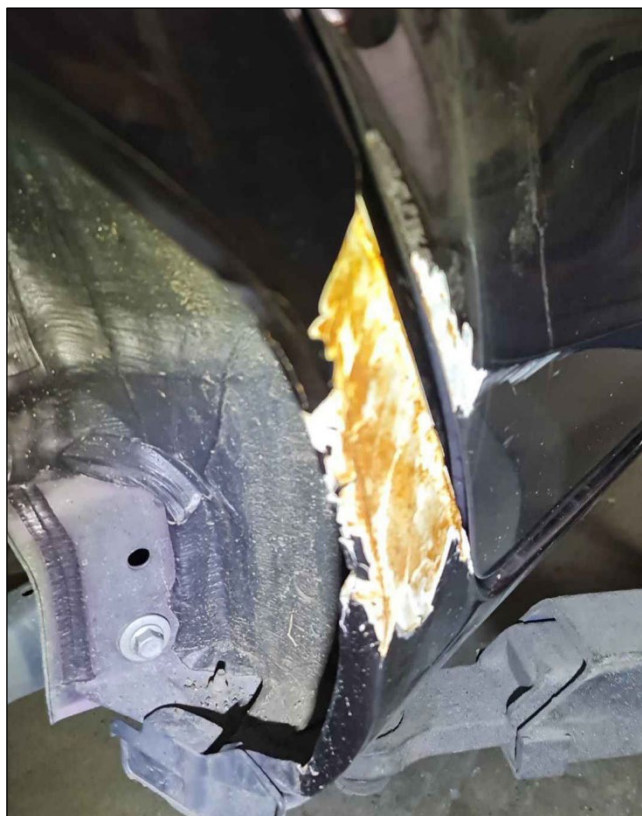
In Images 3 and 4, the overly thick body filler has cracked, delaminated, and fallen out, revealing corrosion to the base metal. The previous repairs have not returned the panel to 'within safe tolerance of the state of the vehicle when manufactured', as the original contours/profiles of the wheel arch and door shut have not been restored (see Images 3 and 4).

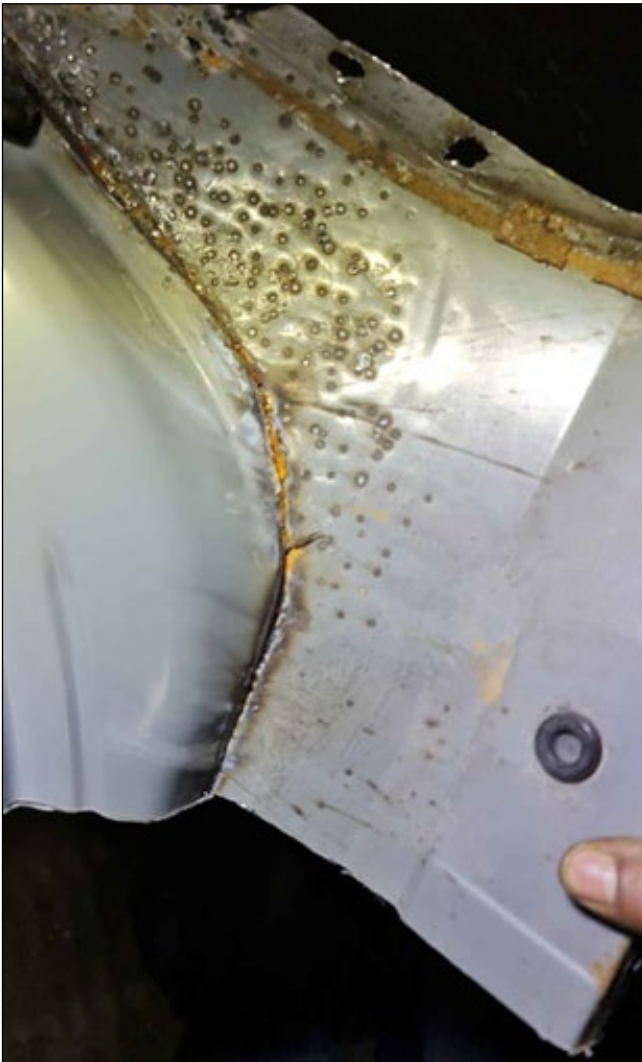
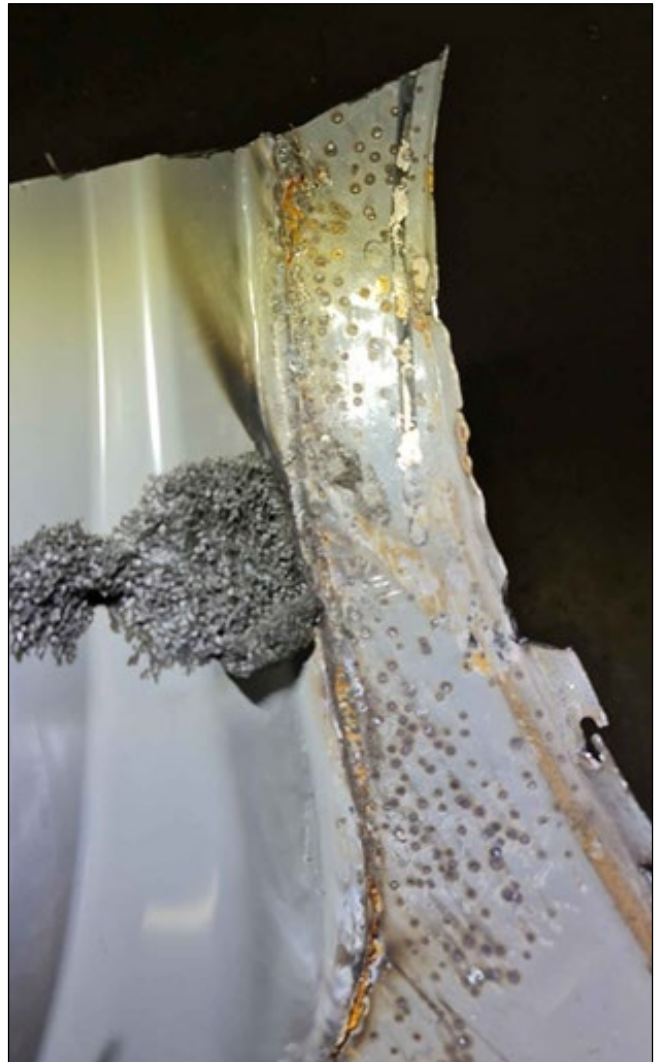
Removal of the previously repaired outer dogleg panel (see Images 3 and 4) reveals the extent of the poorly repaired damage (see Images 5 and 6), in that:

- the NVH element has been burnt and separated; and
- the outer wheel arch profile has been cut and only partially re-welded; and
- extensive (overuse), of the pin pulling process has occurred (which has not restored the proper shape and contours of the panel); and
- damaged corrosion protection coatings have not been restored and rust is starting to appear; and
- sealing materials have been damaged and not restored.
