The Effects of Repairing High Strength Steels

The Importance of Considering the Repairability of High Strength Steels

About RepairCert NZ Technical Bulletins

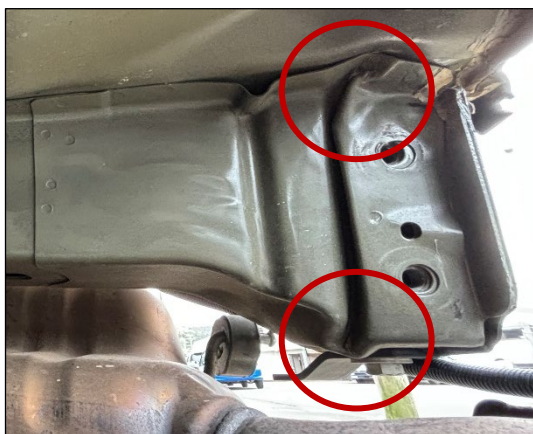
Image 1: In the photograph above left, the rear chassis rail section of a 2018 Holden Captiva is shown in its impact-damaged state. The damaged rail section, which is made from HSLA steel, should have been replaced, however it was (incorrectly) repaired.

Earlier in 2024, a 2018 Holden Captiva was damaged during a rear collision. The Repair Certifier involved was engaged post-repair of the damaged vehicle, and determined, during his repair certification inspection that the right-side rear chassis rail had been damaged in the collision (*see Image 1*), and had been repaired (*see Image 2*) by the collision repairer. The repair involved pin-pulling to facilitate the dent removal process.

The Repair Certifier failed the repair due to the severity of the kinks, requiring the damaged and repaired section to be removed and replaced with a new part, in line with the vehicle manufacturer's recommendations, and best-practice guidance.

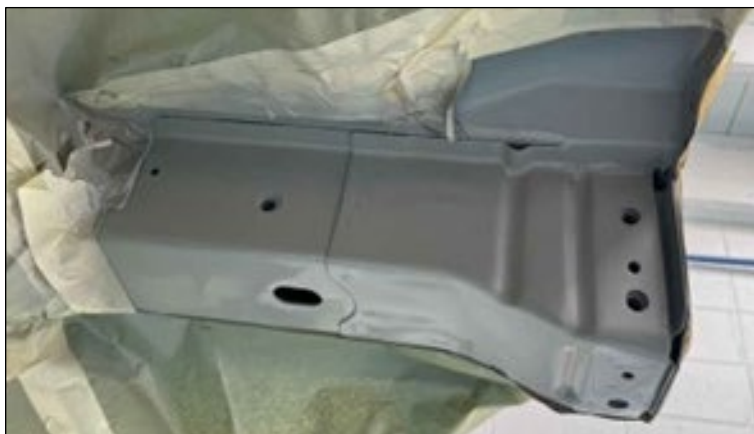
Image 2: In the photograph above right, the impact-damaged rail section is shown after the completion of the (incorrect) repair process.

It should be noted that the heat generated by the pin-pulling process is significant and can reach approximately 2000 degrees Celsius - almost double that allowed by General Motors' guidelines.

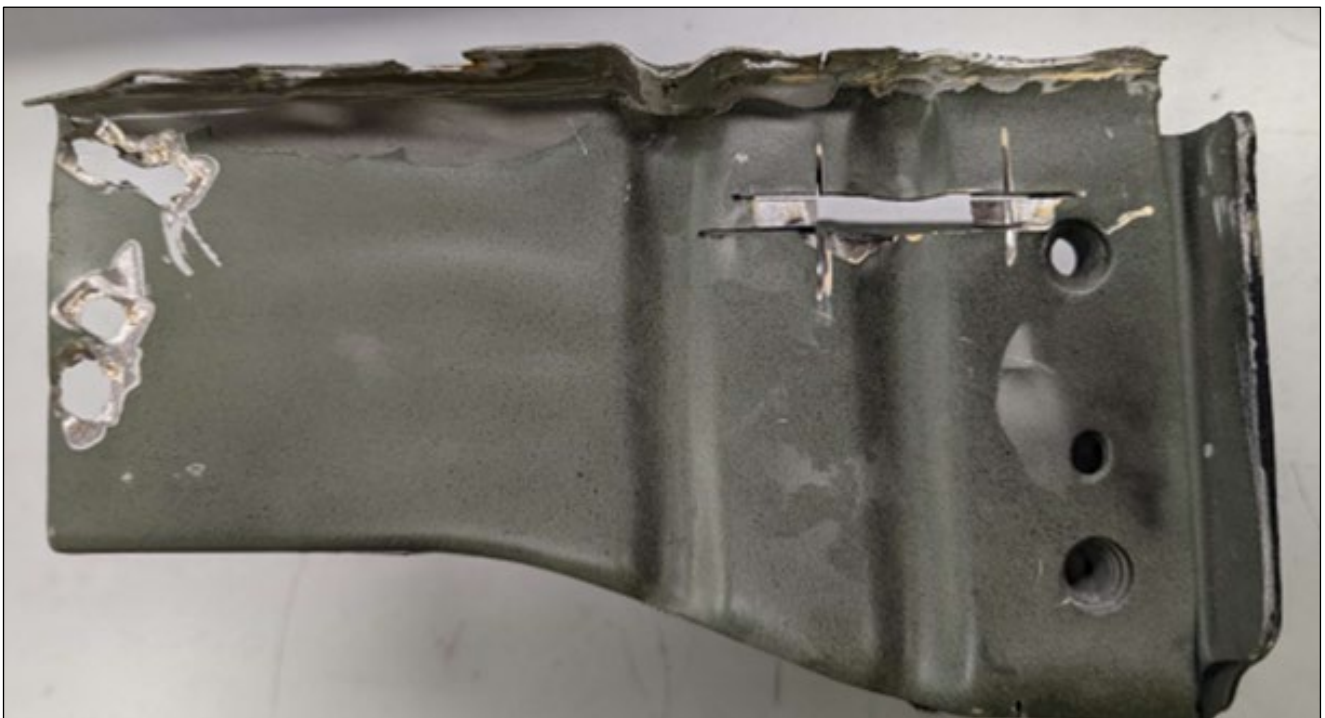
Image 3: The removed damaged and repaired rail section, prior to fitting a new part. The 'slot' cut from the removed section enabled a preliminary inspection of the material to take place.

After stripping the rear chassis rail section, multiple heat-affected areas from the pin-pulling process were found to be present on the damaged and repaired area. As detailed under 'Vehicle Manufacturer's Specifications' above, it is evident that the heat applied to the rear rail section significantly exceeds that allowed by the vehicle manufacturer.

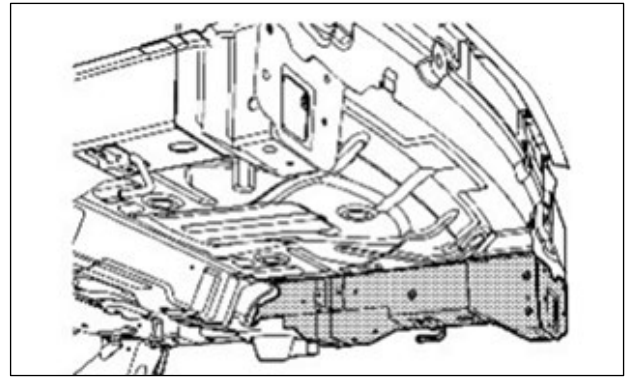
The General Motors Body Repair Manual (BRM) 'Structure Identification' section for the 2018 Holden Captiva lists the chassis section as a 'Rear Rail' (*see Image 4*) and specifies the material as 'High Strength Low Alloy Steel'. It also specifies that the correct repair procedure for kinked steel is 'part replacement'.

- 'cold repairs can be performed on this type of steel, unless the damage includes kinks. If the damage includes kinks, the part should be replaced'; and
- 'controlled use of heat can be used to repair damage, if the heat does not exceed 1200 degrees Fahrenheit (650 degrees Celsius)'.

Image 4: The 'Rear Rail' from General Motors' BRM.

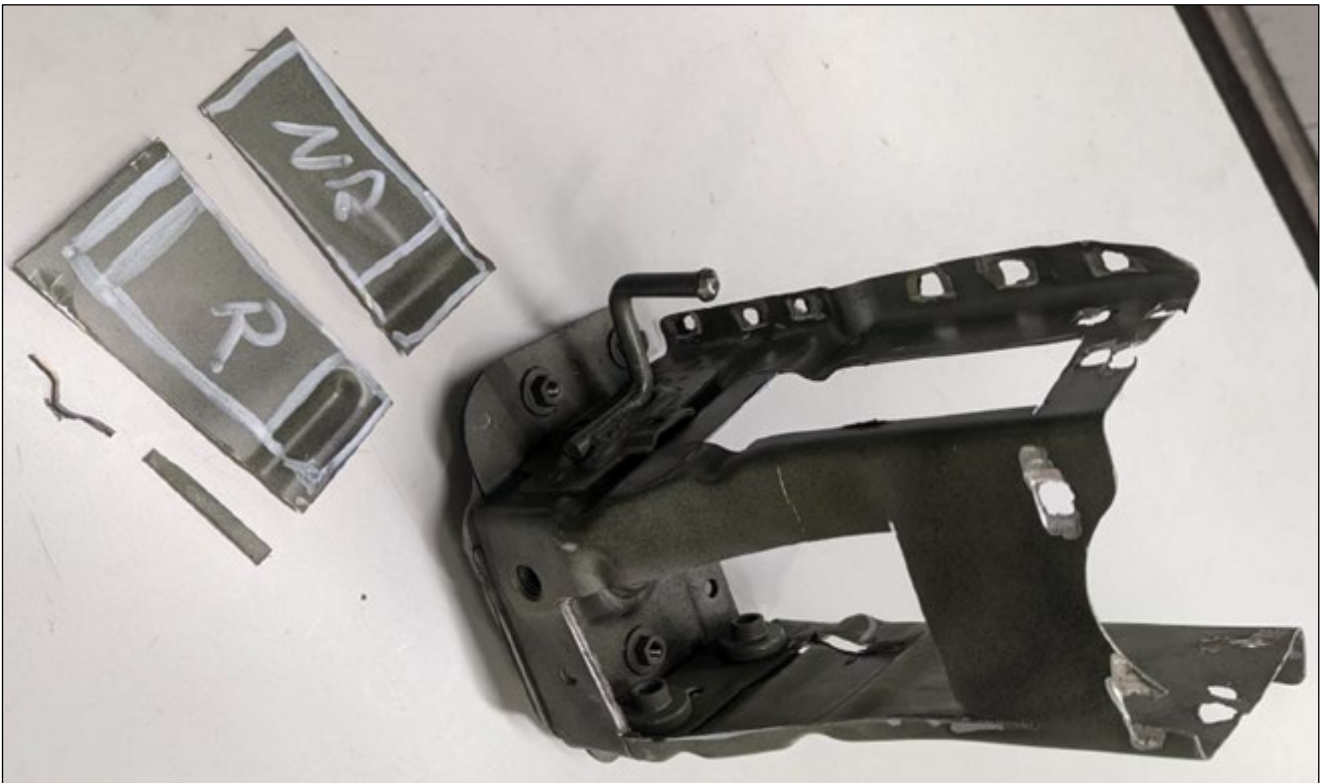
Image 5: This photograph shows the extracted samples cut from the chassis section, and marked 'R' (Repaired), and 'NR' (Not Repaired).

The microscopic analysis concluded that the grain structure of the 'R' sample has been significantly altered from that which could be viewed in the 'NR' sample. Specifically, the ductility of the 'R' sample has been substantially reduced from the level of ductility in the 'NR' sample.

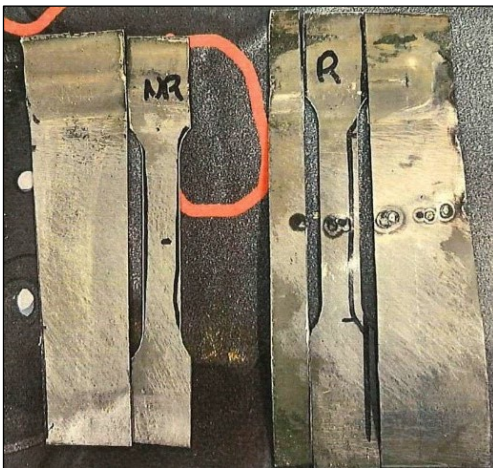
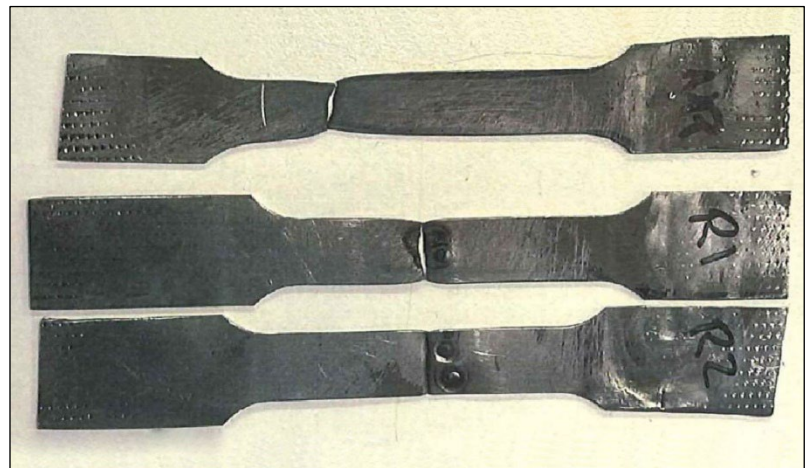
The tensile testing carried out showed a significant difference in the performance of the two sections from the 'R' sample compared to the section from the 'NR' sample (*see Images 6 and 7*). The loss of ultimate tensile strength in the 'R' samples was relatively minor at between 8% and 14% reduction.

However, the ductility (the material's ability to bend and stretch rather than fracture or shatter) of the chassis rail section was massively compromised as a result of the heating that had been applied to the material during the pin-pulling process. A tensile test was carried out on two sections of the 'R' sample, and one section of the 'NR' sample.

On the two 'R' sample tensile tests, the ductility was found to have been reduced, from the 'NR' sample test, by 92% and 70% respectively.

Image 6: The tensile strength sections have been roughly cut to shape from the 'R' and 'NR' samples.

Image 7: The tensile test sections have been finished, and clamped, and had a load applied until the sections have failed, with the load information telling the story.

The significance of this result can't be understated because the ductility of the material is crucial to the chassis rail's collision performance. Had the vehicle (still fitted with the damaged and repaired chassis rail section) been involved in another rear collision, the material would almost certainly have collapsed in an uncontrolled manner instead of doing its important job of progressively deforming, and thereby reducing the impact energy on the occupants. This is particularly relevant on this vehicle, because of the proximity of the third-row seats and associated seatbelt anchorages to the repaired rear chassis rail section.

'It is reasonable to conclude that any repair effort that involves heat sufficient to melt steel, or mechanical action to restore the shape of bent or kinked areas of modern automotive steel is going to impair the designed level of safety of that part, justifying industry and regulatory expectations that modern steel chassis sections must be fully replaced, not repaired, in the event of damage.'

Based on this reinforcement of what we've always understood to be 'Best-practice', RepairCert NZ strongly urges Repair Certifiers to exercise diligence when considering the repairability (or non-repairability) of components which the vehicle manufacturer lists as being made of HSS materials, especially in safety-critical areas of a motor vehicle - and even more so where they form part of the vehicle's occupant protection system.
