The Effects of Repairing High Strength Steels

The Importance of Considering the Repairability of High Strength Steels

About RepairCert NZ Technical Bulletins

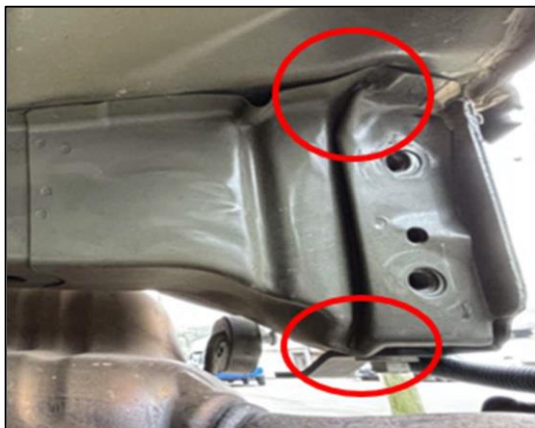
Image 1: In the photograph above left, the rear chassis rail section of a 2018 Holden Captiva is shown in its impact-damaged state. The damaged rail section, which is made from HSLA steel, should have been replaced, however it was (incorrectly) repaired.

Earlier in 2024, a 2018 Holden Captiva was damaged during a rear collision. The Repair Certifier involved was engaged post-repair of the damaged vehicle, and determined, during his repair certification inspection that the right-side rear chassis rail had been damaged in the collision (*see Image 1*), and had been repaired (*see Image 2*) by the collision repairer. The repair involved pin-pulling to facilitate the dent removal process.

The Repair Certifier failed the repair due to the severity of the kinks, requiring the damaged and repaired section to be removed and replaced with a new part, in line with the vehicle manufacturer's recommendations, and best-practice guidance.

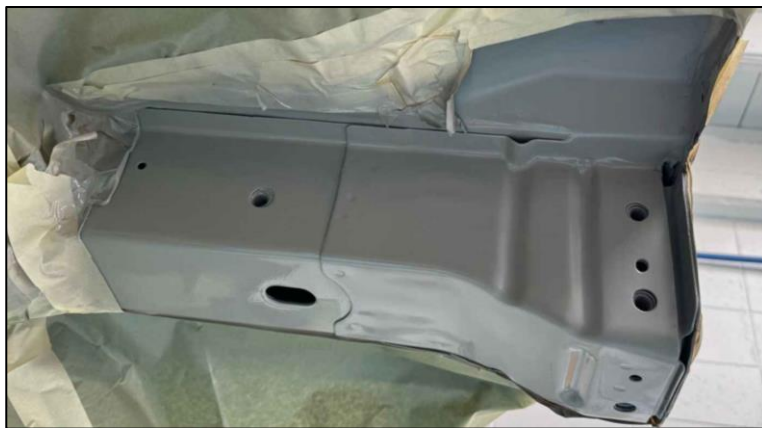
Image 2: In the photograph above right, the impact-damaged rail section is shown after the completion of the (incorrect) repair process.

After stripping the rear chassis rail section, multiple heat-affected areas from the pin-pulling process were found to be present on the damaged and repaired area. As detailed under 'Vehicle Manufacturer's Specifications' above, it is evident that the heat applied to the rear rail section significantly exceeds that allowed by the vehicle manufacturer.

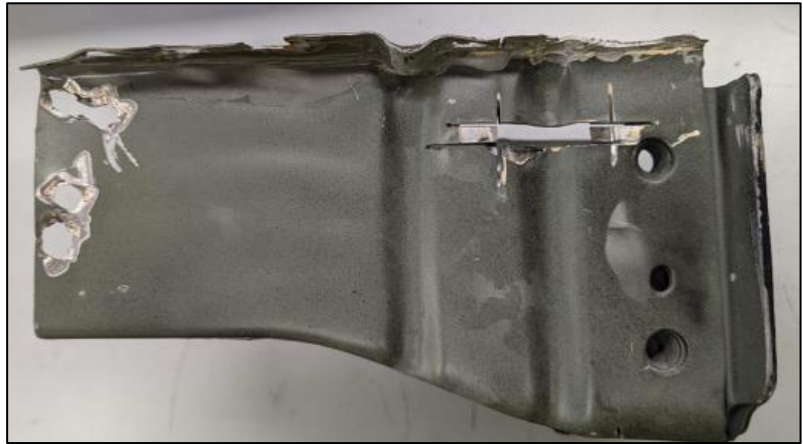
RepairCert NZ supported the Repair Certifier during his repair certification inspection, and also took the opportunity to take possession of the damaged and repaired chassis rail section (*see Image 3*), and have the section analysed and tested by Hayes Laboratories to learn what effects the repair process had on the HSLA material the rail is made from.

Image 3: At right is the removed damaged and repaired rail section, prior to fitting a new part. The 'slot' cut from the removed section enabled a preliminary inspection of the material to take place.

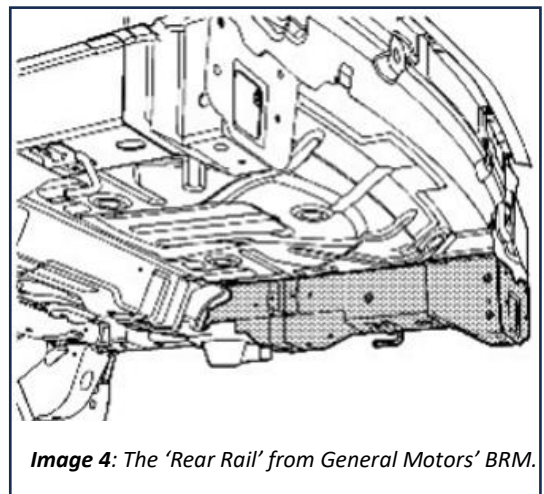
The General Motors Body Repair Manual (BRM) 'Structure Identification' section for the 2018 Holden Captiva lists the chassis section as a 'Rear Rail' (*see Image 4*) and specifies the material as 'High Strength Low Alloy Steel'. It also specifies that the correct repair procedure for kinked steel is 'part replacement'.

- 'cold repairs can be performed on this type of steel, unless the damage includes kinks. If the damage includes kinks, the part should be replaced'; and
- 'controlled use of heat can be used to repair damage, if the heat does not exceed 1200 degrees Fahrenheit (650 degrees Celsius)'.

Image 4: The 'Rear Rail' from General Motors' BRM.

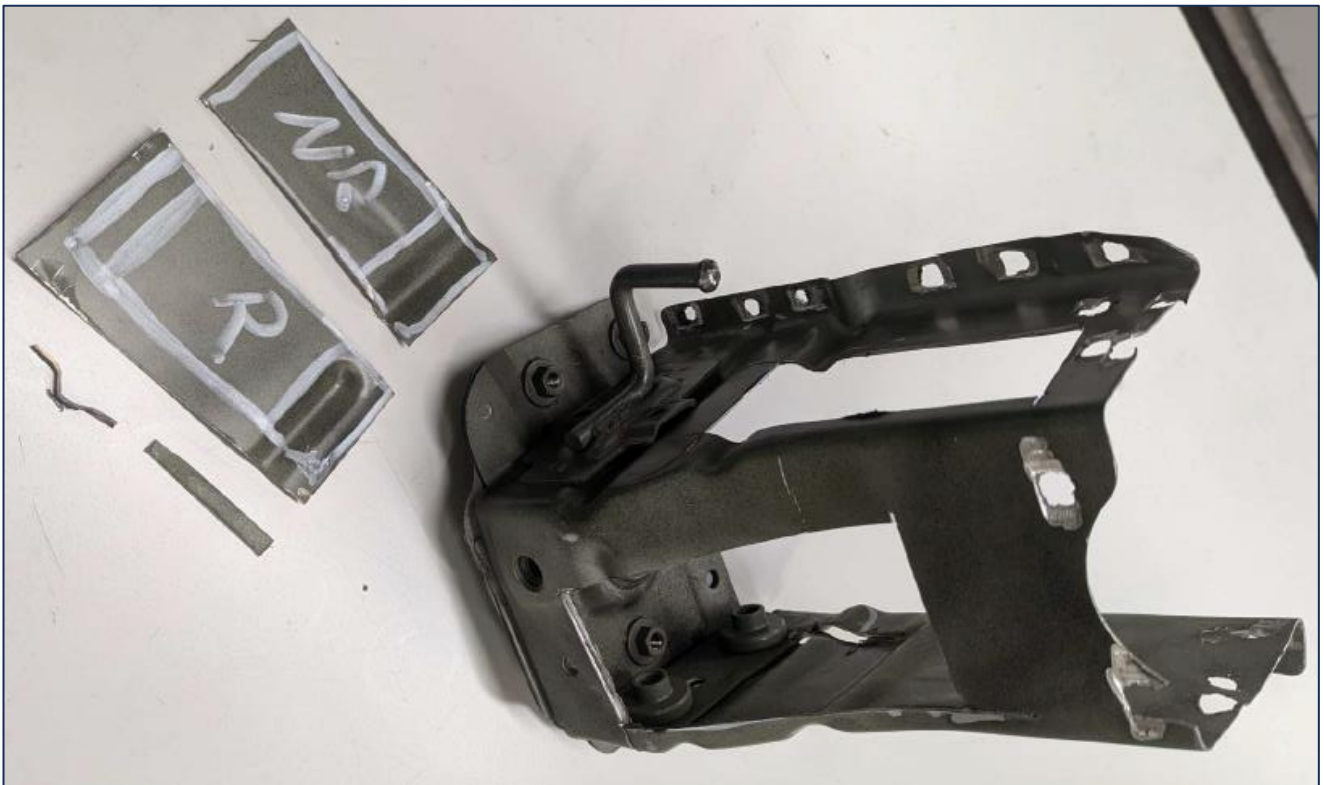
Once in the expert hands of the Hayes Laboratories technicians, two samples of material were cut from the chassis section, each approximately 60 mm x 175 mm in size. One sample (designated 'sample NR' – for 'Not Repaired') was cut from the side of the chassis rail section which had not been damaged and repaired, while the other sample (designated 'sample R' – for 'Repaired') was taken from the damaged and repaired side of the chassis rail section, and included an area which directly overlapped the repaired area of the rail (see Image 5).

Image 5: This photograph shows the extracted samples cut from the chassis section, and marked 'R' (Repaired), and 'NR' (Not Repaired).

The microscopic analysis concluded that the grain structure of the 'R' sample has been significantly altered from that which could be viewed in the 'NR' sample. Specifically, the ductility of the 'R' sample has been substantially reduced from the level of ductility in the 'NR' sample.

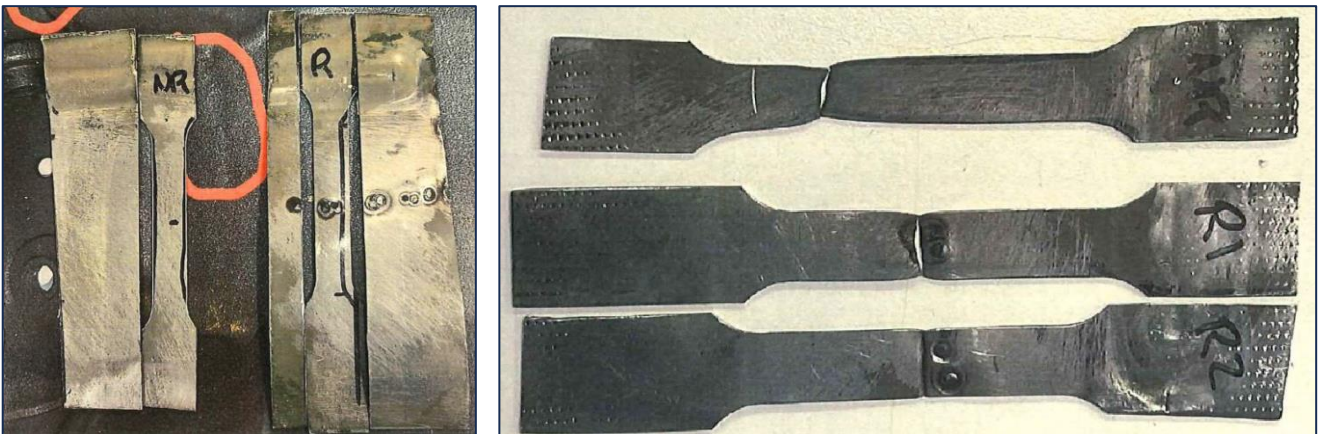
The tensile testing carried out showed a significant difference in the performance of the two sections from the 'R' sample compared to the section from the 'NR' sample (*see Image 6*). The loss of ultimate tensile strength in the 'R' samples was relatively minor at between 8% and 14% reduction.

However, the ductility (the material's ability to bend and stretch rather than fracture or shatter) of the chassis rail section was massively compromised as a result of the heating that had been applied to the material during the pin-pulling process. A tensile test was carried out on two sections of the 'R' sample, and one section of the 'NR' sample.

On the two 'R' sample tensile tests, the ductility was found to have been reduced, from the 'NR' sample test, by 92% and 70% respectively.

Image 6: In the photograph above left, the tensile strength sections have been roughly cut to shape from the 'R' and 'NR' samples.

Image 7: In the photograph above right, the tensile test sections have been finished, and clamped, and had a load applied until the sections have failed, with the load information telling the story.
