## Steering System Damage Analysis

### Correct Identification and Evaluation of Steering System Damage

Supporting New Zealand's Repair Certification Industry

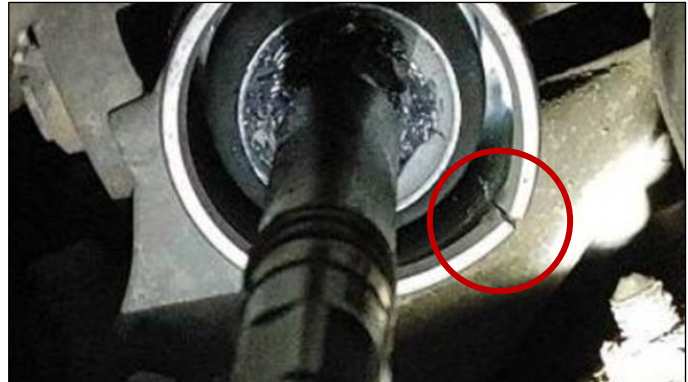
- Cracks, splits, or fractures (irrespective of size and location) in the (predominately) cast aluminium rack housing can lead to complete steering system failure (see Image 10).

**Image 10:** A crack/fracture in the steering rack housing.

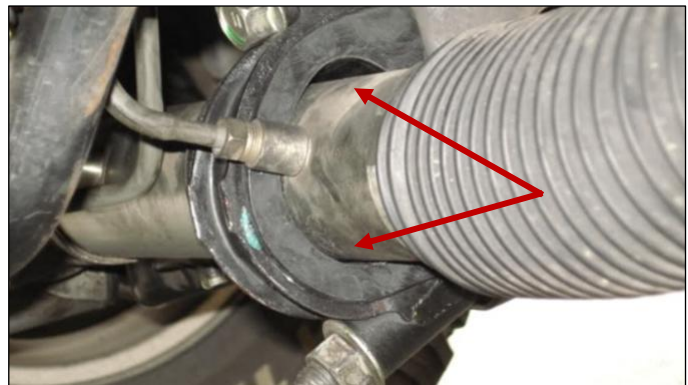
- Bent or distorted mounting points and mounting hardware (that attach the steering rack to the vehicle) may cause the steering rack assembly to no longer be retained securely or remain in its original attachment position. This will affect wheel alignment geometry/alignment angles and steering 'lock-to-lock' functionality. Clunking noises and erratic steering behaviour may also become apparent (see Image 11).
- Cracked or split mounting lugs (on the steering rack housing) can allow the steering rack assembly to flex and move around, creating erratic steering behaviour which can ultimately lead to complete detachment (see Image 12).
- Split, displaced or worn mounting bushes can allow the steering rack assembly to move around, creating clunking sounds and erratic steering behaviour (see Images 13 and 14).

**Image 11:** Bent or distorted mounting points and mounting hardware.

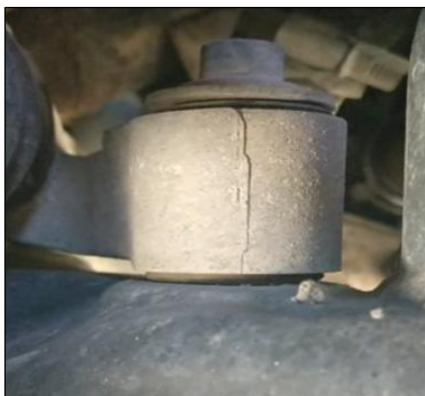
**Image 12:** A cracked steering rack mounting lug.

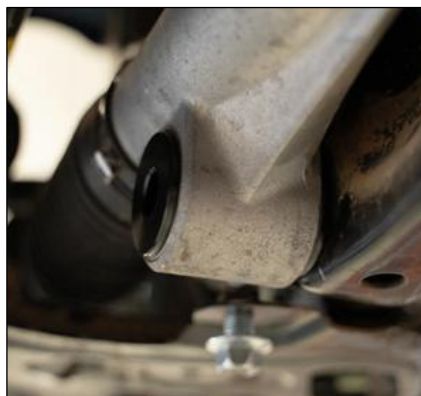
**Image 13:** Example of mounting bush damage.

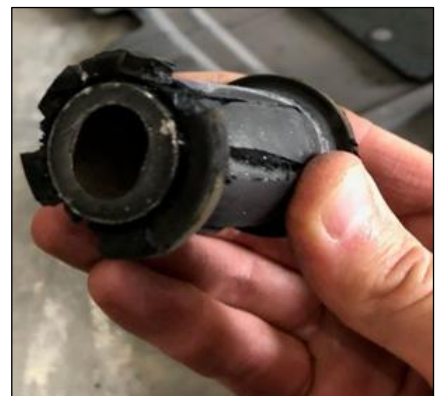
**Image 14:** Example of mounting bush damage.

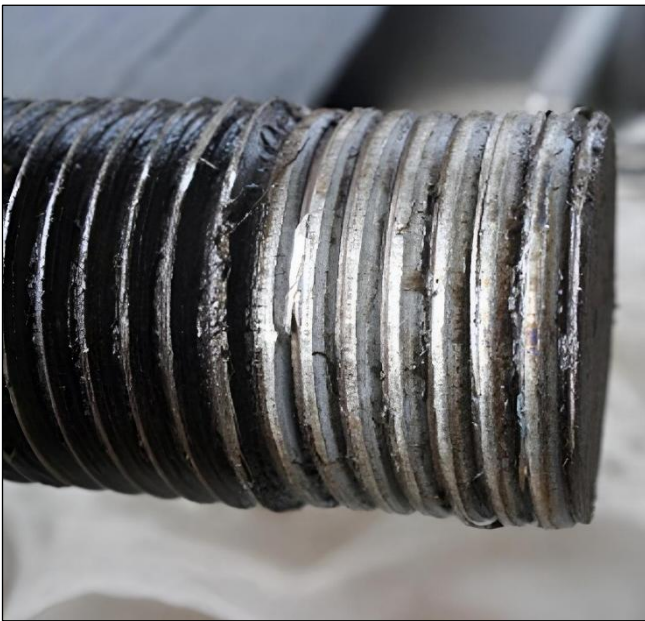
**Image 18:** Distorted and stripped the threads.

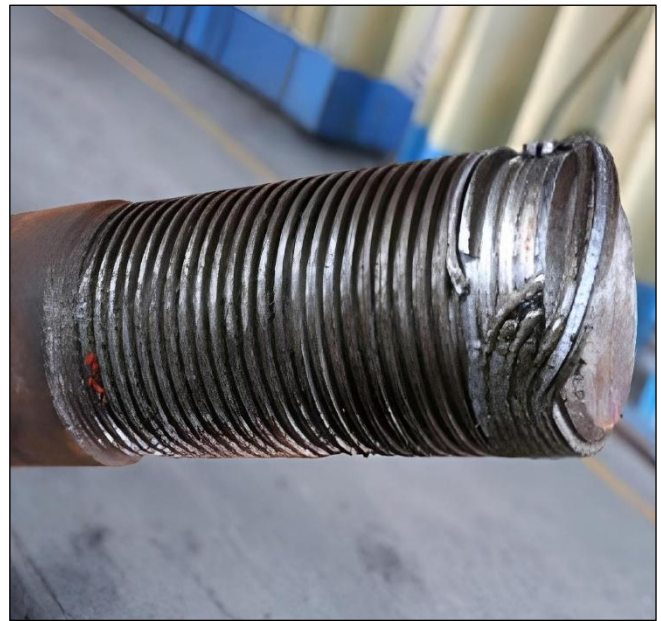
**Image 19:** Torn threads.

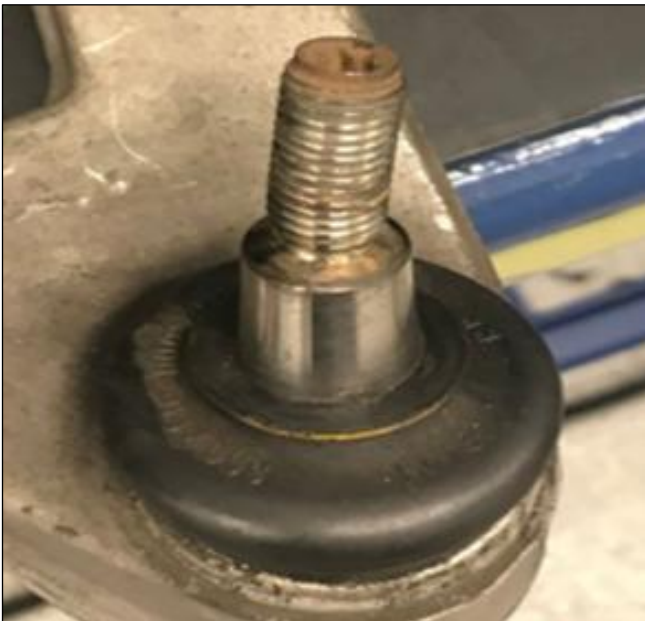
**Image 20:** Bent ball joint threaded shaft.

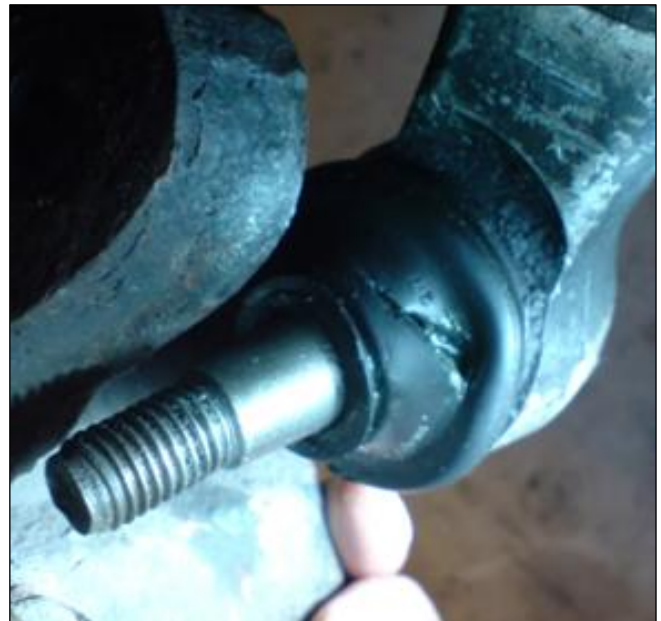
**Image 21:** Protective rubber boot damage.

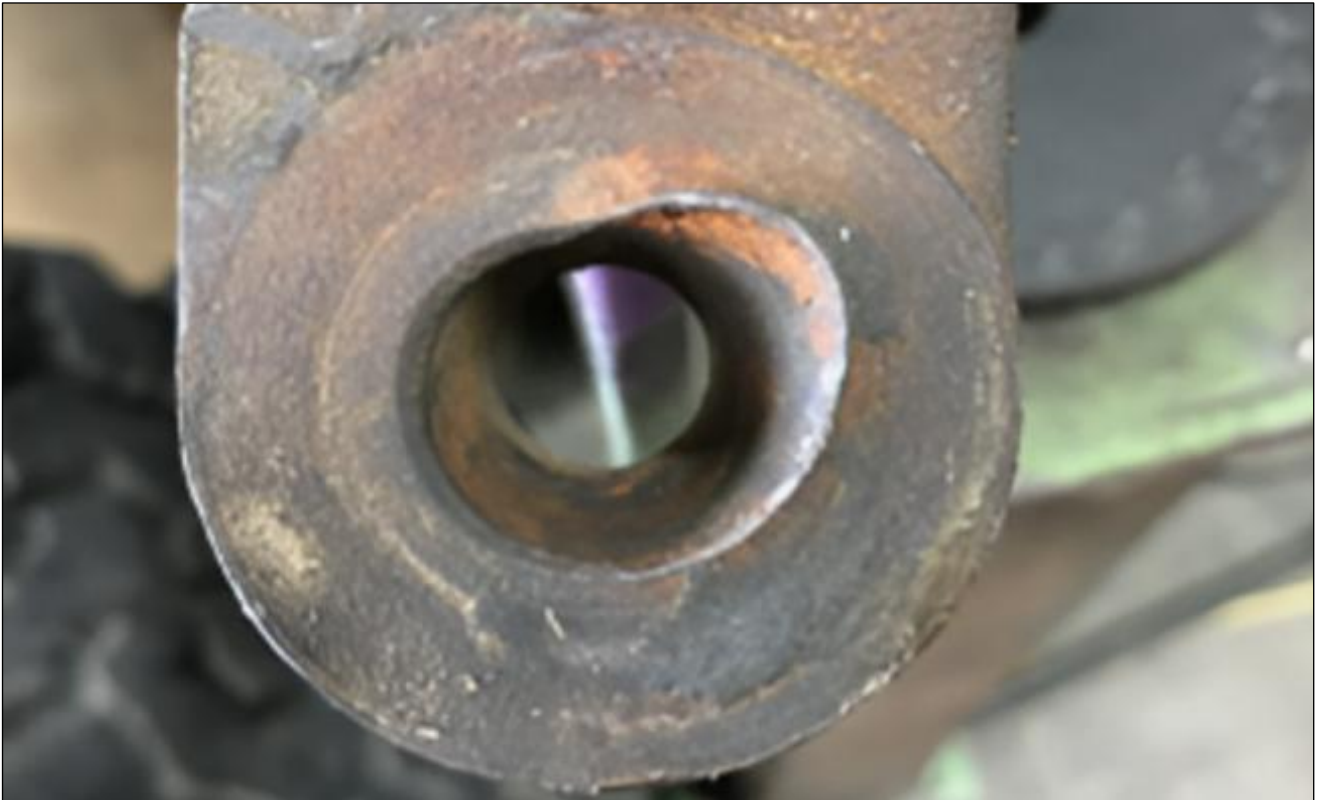
- looseness in the connection between the ball joint and the component that it connects to (i.e. a steering knuckle) – even though the threaded retainer nut has not been loosened. This happens when the matching taper on the component (i.e. a steering knuckle) that the ball joint shaft fits into, has been distorted, breaking the taper lock between the two components (see Image 22); or

**Image 22:** The tapered hole on this steering knuckle has been distorted from an impact, breaking the taper lock between it, and the connecting tie rod ball joint.

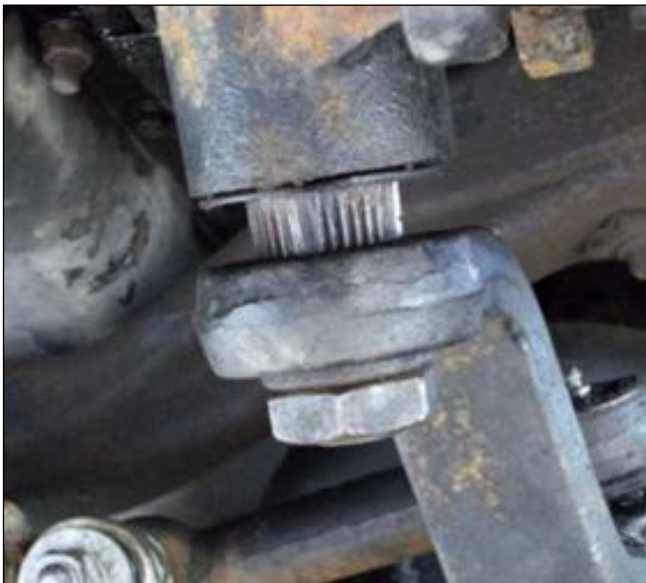
Of the various moving components that make up the steering gearbox, the most common to be damaged in an impact is the sector shaft - a safety critical component that is often overlooked because virtually the entire sector shaft is hidden from view inside the steering gearbox housing (and also by the pitman arm) (see Image 30).

**Image 30:** Very little of the sector shaft is visible for inspection.

Inspection of the sector shaft first requires the removal of the pitman arm (see Note 4). In most circumstances this is able to be performed with the steering gearbox still attached to the vehicle. With the pitman arm removed, the sector shaft can then be closely examined for damage (see image 31).

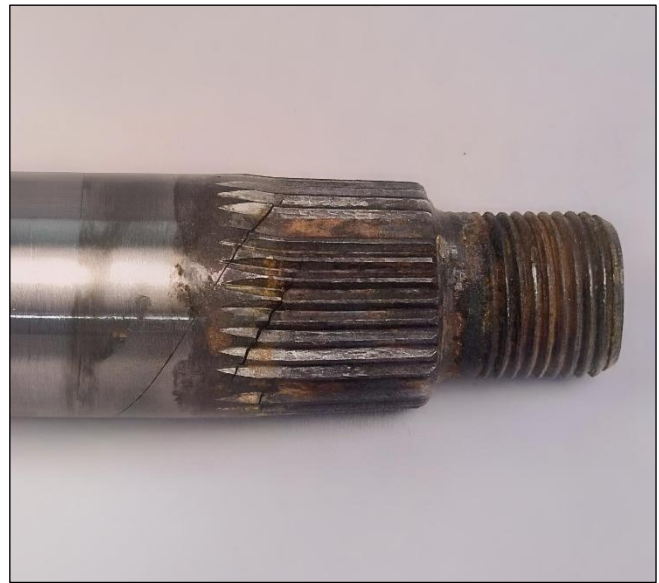
- twisting of the tapered splines; and
- cracks or fractures in the tapered splines and/or the shaft.

**Image 31:** Example of a cracked and twisted sector shaft.

- Twisted sector shaft splines change steering toe angle - unfortunately, because toe angle has a wide range of adjustment on parallelogram steering systems, inexperienced wheel alignment technicians will often just re-adjust the toe angle back to specification, unaware that the sector shaft may be twisted.
- Of major concern are sector shaft cracks that go undiagnosed. A cracked sector shaft could fail completely at any time, resulting in a sudden, catastrophic loss in steering.
- Damaged sector shafts are not repairable and should be replaced. In most instances, the complete steering box assembly is replaced, rather than just the sector shaft.
