REPAIRCERT NZ UPDATE

UPDATE No. 21 | 22/05/2023

File Reviews

TSG IN00003 Prius C Floor Damage

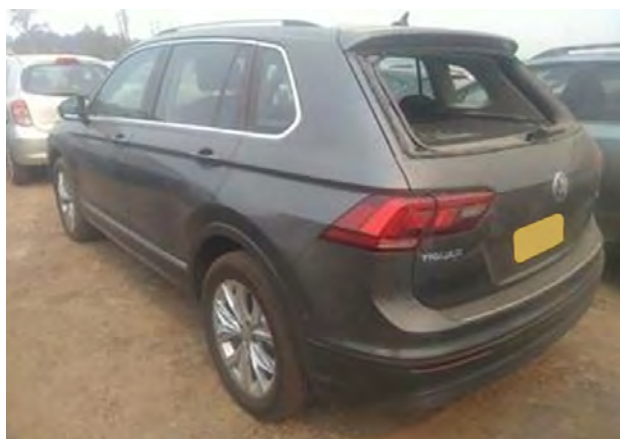
Example 1: 2017 VW Tiguan

A Repair Certifier was overseeing the repair certification of a hail damaged vehicle imported from Australia. The initial inspection and single auction house photo showing only the front of the vehicle, determined that roof skin replacement and conventional repairs to both cant rails, were required. The Repair Certifier was well aware that the damage descriptions of many Australian statutory write-offs are misrepresented, and often involve deceptive practices and fraudulent behaviour. Therefore, the Repair Certifier insisted that more auction house photos were needed to clarify and confirm the extent of the damage. Those additional photos clearly showed the vehicle had been sitting in an open salvage yard in Australia - with a smashed rear screen.

With this information to hand, the vehicle is now classified as water damaged, which necessitates the replacement of (or repairs to) a substantial number of safety and electrical components as required by the *Light vehicle repair certification VIRM (General Repairs, Water damage, Tables and images, Table 9-1-1, Water damaged vehicle safety related components)*, before it can be considered safe and compliant. As we are all well aware, the costs associated with following the requirements of Table 9-1-1 are significant, and may now make this vehicle uneconomical to repair.

It is strongly recommended by RepairCert NZ and Waka Kotahi that you obtain auction house photos, or ask the owner to provide them.

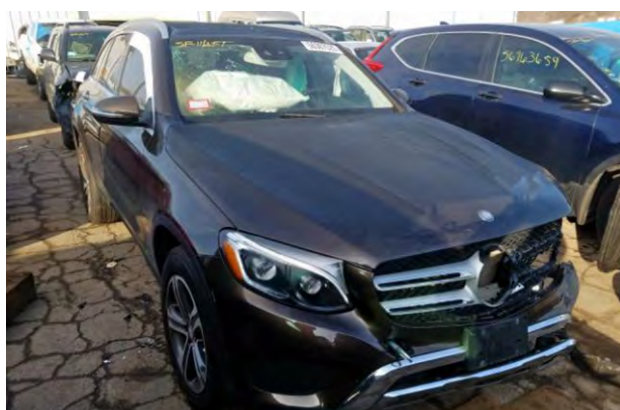
Example 2: 2020 Mercedes Benz GLC

This vehicle was presented to the Repair Certifier as a New Zealand de-registered insurance write-off with significant frontal damage (including suspension). The Repair Certifier's suspicions were aroused regarding the original condition of the vehicle, by the fact that there were no SRS/Airbag deployments, when experience would suggest that these would have activated after a frontal impact of this severity.

Before issuing any repair instructions, the Repair Certifier acquired auction house photos of the vehicle in its original damaged condition, which clearly showed airbag and pretensioner deployments - confirming the Repair Certifier's suspicions.

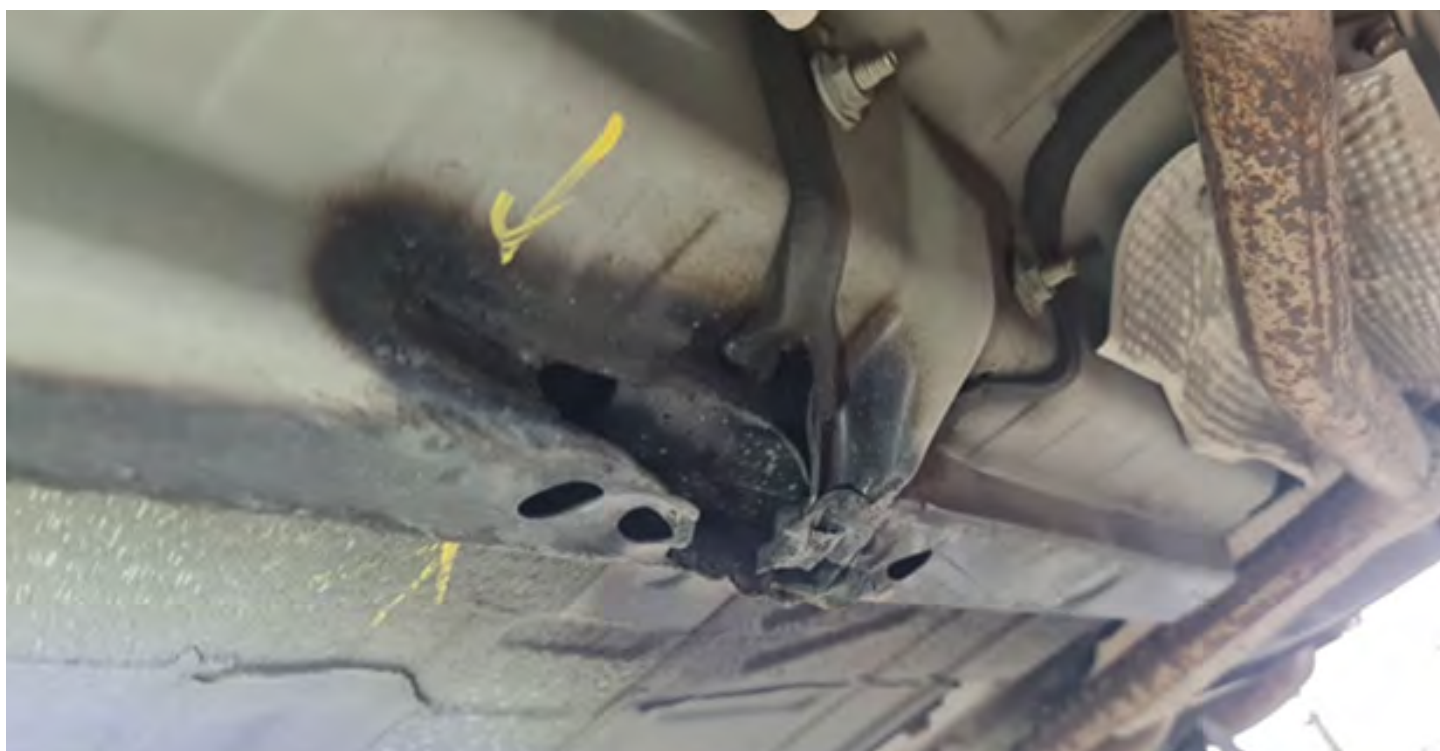
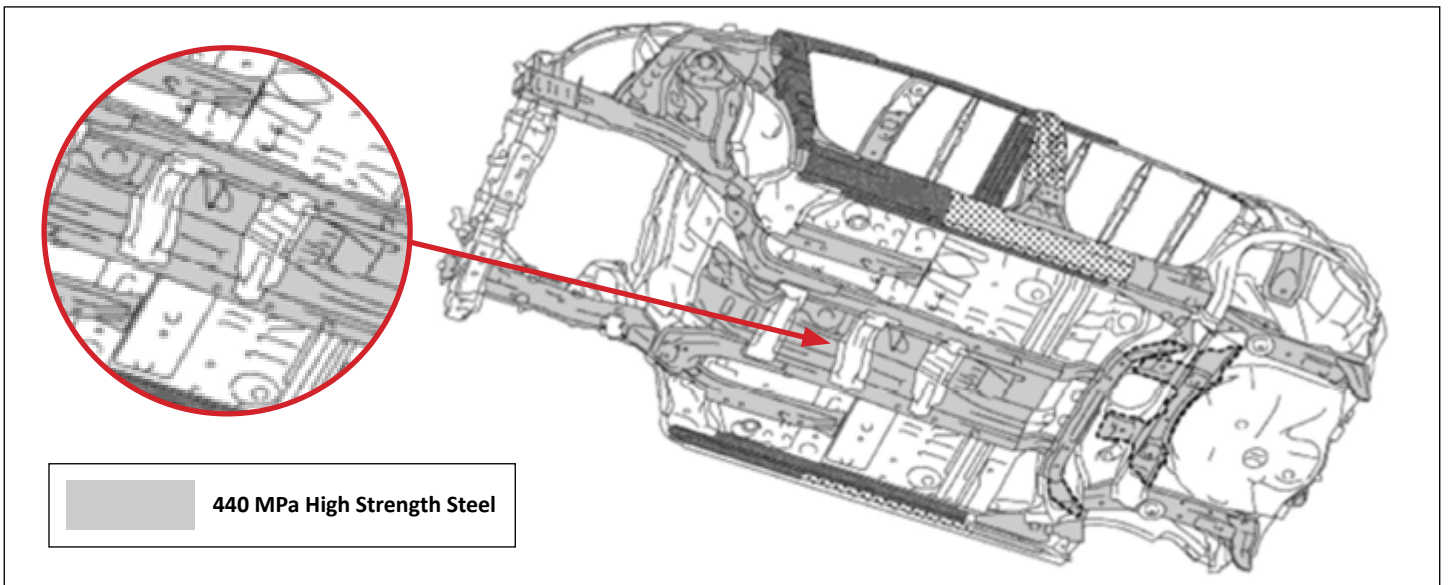
The Repair Certifier of this vehicle approached Repaircert NZ seeking guidance on a 'best practice' repair process for a crushed and torn centre floor brace on a 2013 Toyota Prius C hybrid. ►

- Toyota do not provide a replacement procedure for this part; and
- the damaged component is constructed of 440MPa tensile strength steel; and
- second-hand parts will be used; and
- Toyota do not allow sectioning of structural parts without a procedure.

Having the opportunity for the TSG Members to discuss the finer details of this technical inquiry in-person proved to be very beneficial in providing an outcome, that was (with one exception) unanimous in supporting the Repair Certifier's proposal to partially section the damaged floor brace using a second-hand part, rather than requiring full component replacement at the factory connection points.
