Multi-panel Sub-assembly Replacement

Guidance on Replacing Multiple Inner and Outer Components as Sub-assemblies

About RepairCert NZ Technical Bulletins

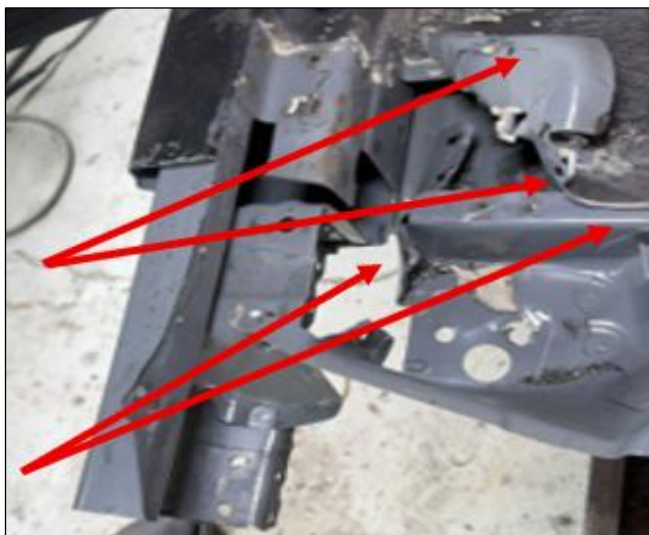
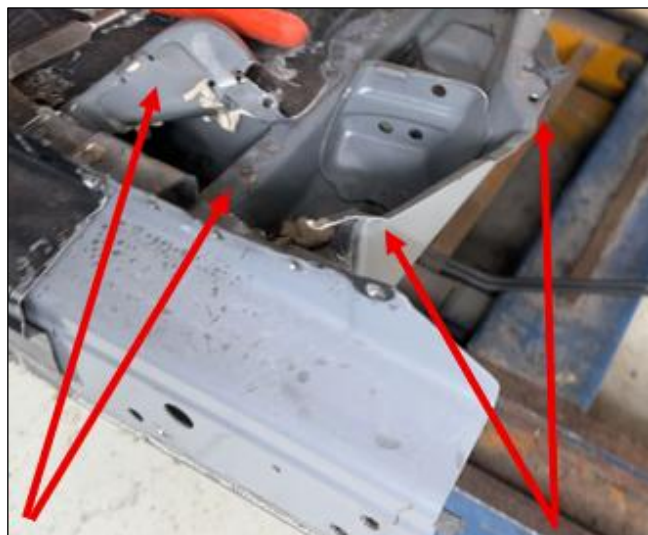
- all required welds are completed; and
- the weld locations are readily accessible without peeling back or cutting out adjacent welded components (including sectioning of outer body panels) to gain access to welded connections (unless specified in a manufacturer’s procedure) (see *Images 8 to 11* on Page 8).

Images 8 and 9: In these examples of what must not be done, adjacent welded components have been peeled back to access the inner weld points.

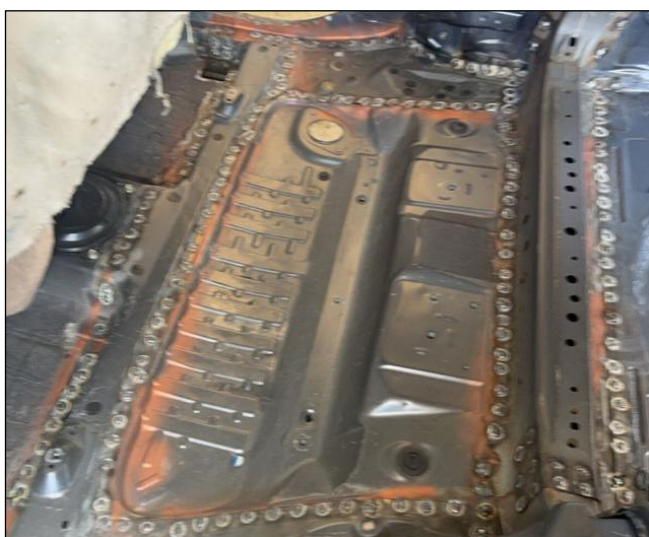
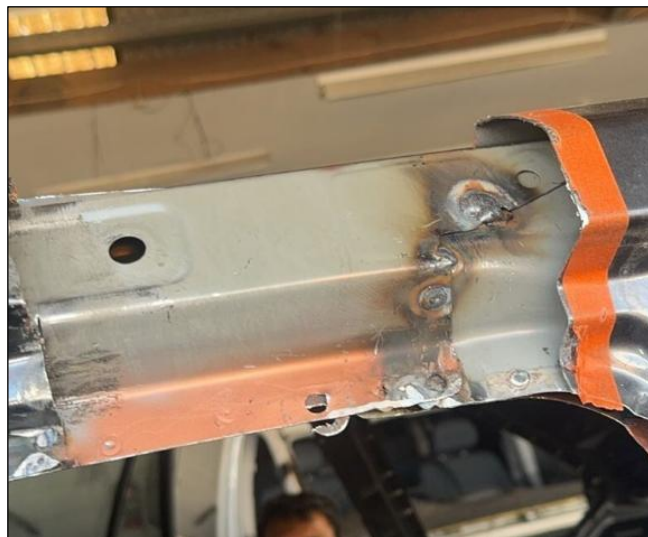
Images 10 and 11: In these further examples of what must not be done, adjacent welded components have been either fully removed (Image 10), or sectioned (Image 11), to access the inner weld points.

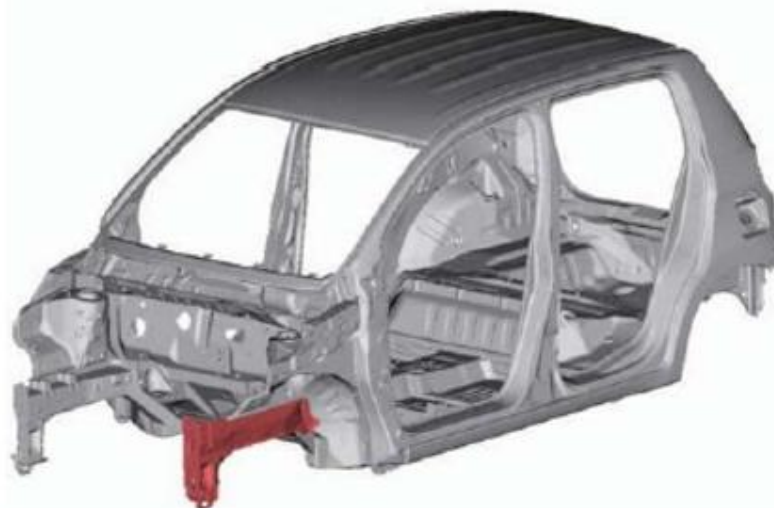
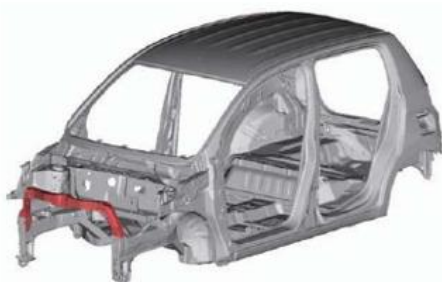
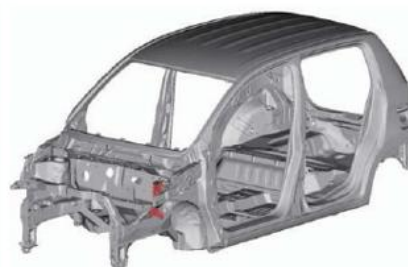
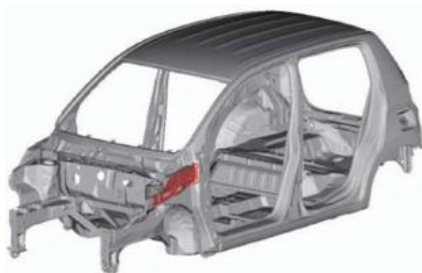
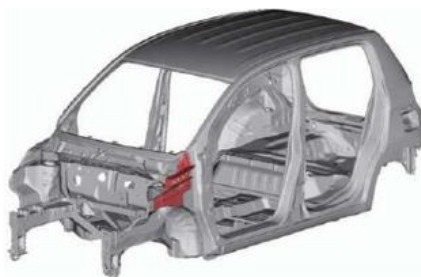
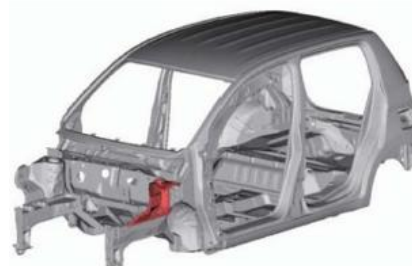
- While some vehicle manufacturers provide information on the replacement of multiple individual replacement weld-on components within a single procedure, many others don't - requiring the autobody technician to procure and navigate through multiple replacement procedure documents (see *Image 21* on Page 13).

This increases the risk of critical steps that need to be followed in the replacement of multiple components at the same time being misinterpreted, performed out of sequence, or overlooked altogether.

Image 21: In this Suzuki example, there are five individual procedures required to replace the front inner guard and chassis rail structure.

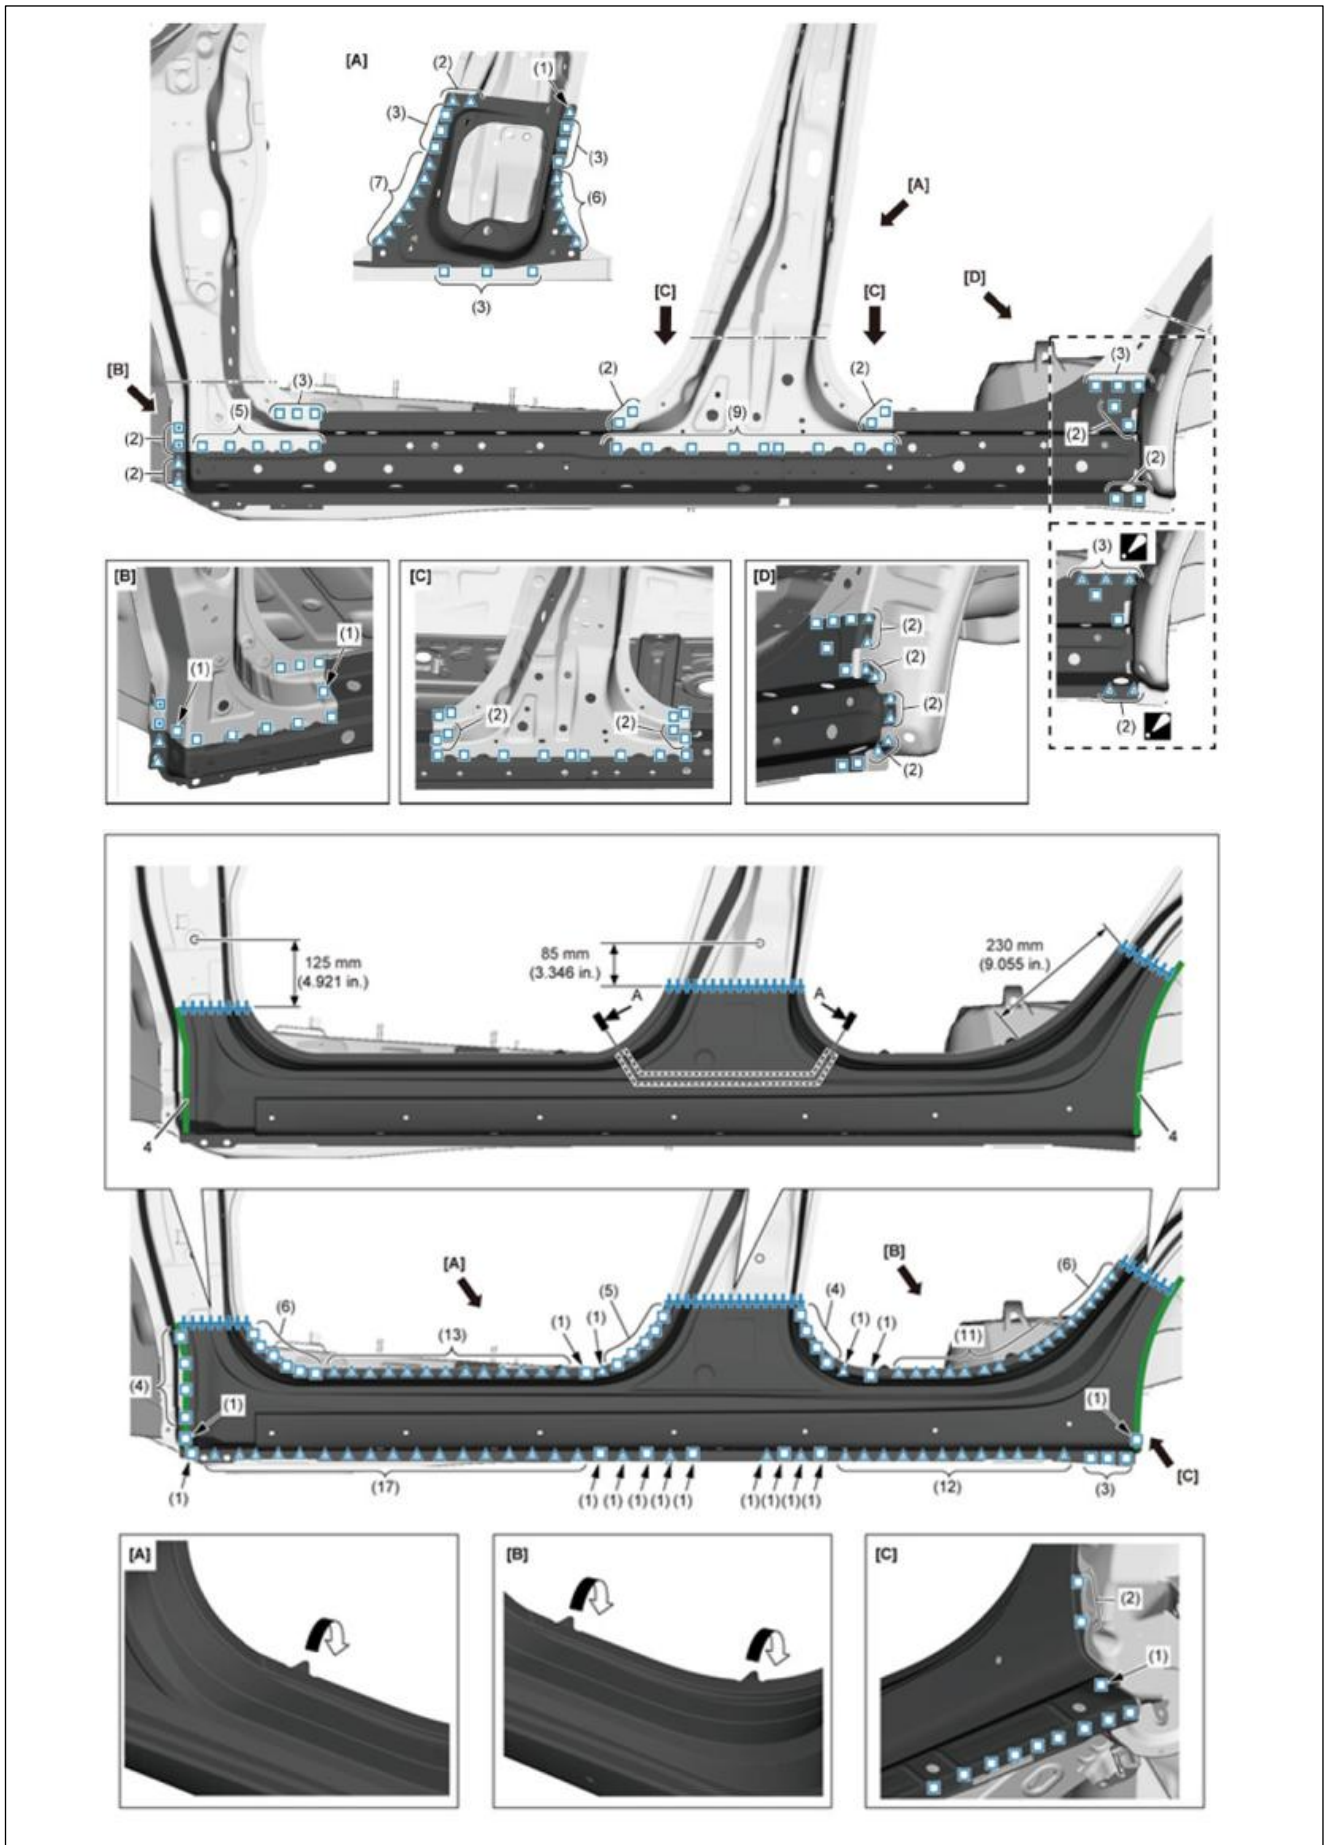
- Identifying the location or orientation of replacement welds within the 'panel stack' (or multi-panel layers) often means that different welding methods (other than those originally used by the vehicle manufacturer), or the installation of welds at strategic stages of the replacement process (that is, before the next panel layer can be installed), or both, will be required (see *Image 22* on Page 14).

Image 22: Inner and outer sill/rocker replacement procedure excerpts from a Suzuki BRM.

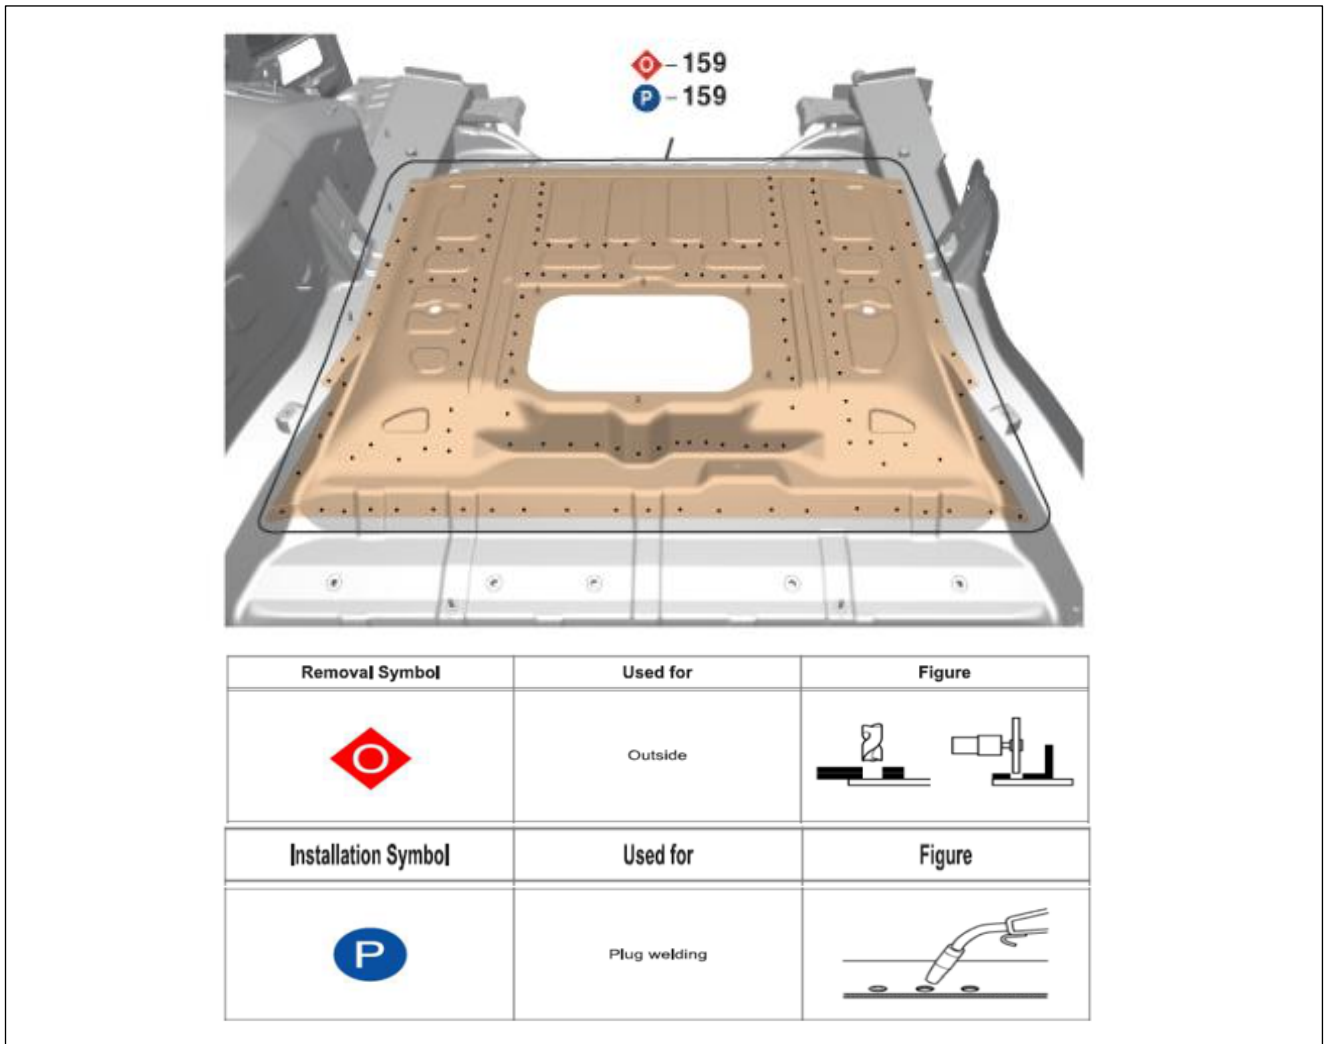
- The large numbers of factory welds on the individual mating flange joints of multiple adjacent or connected components and structures (e.g. brackets, cross-members, and reinforcements) that require removal and subsequent re-welding, can be difficult and time-consuming to replicate in quality and appearance, significantly compromise original corrosion protection, and generate substantial additional heat, increasing the heat-affected zone (HAZ) on existing mating flanges (see *Image 23* on Page 15).

Image 23: A Hyundai Boot Floor Replacement Procedure showing the large number of welds that are required to re-attach all the associated individual components to the new replacement panel.

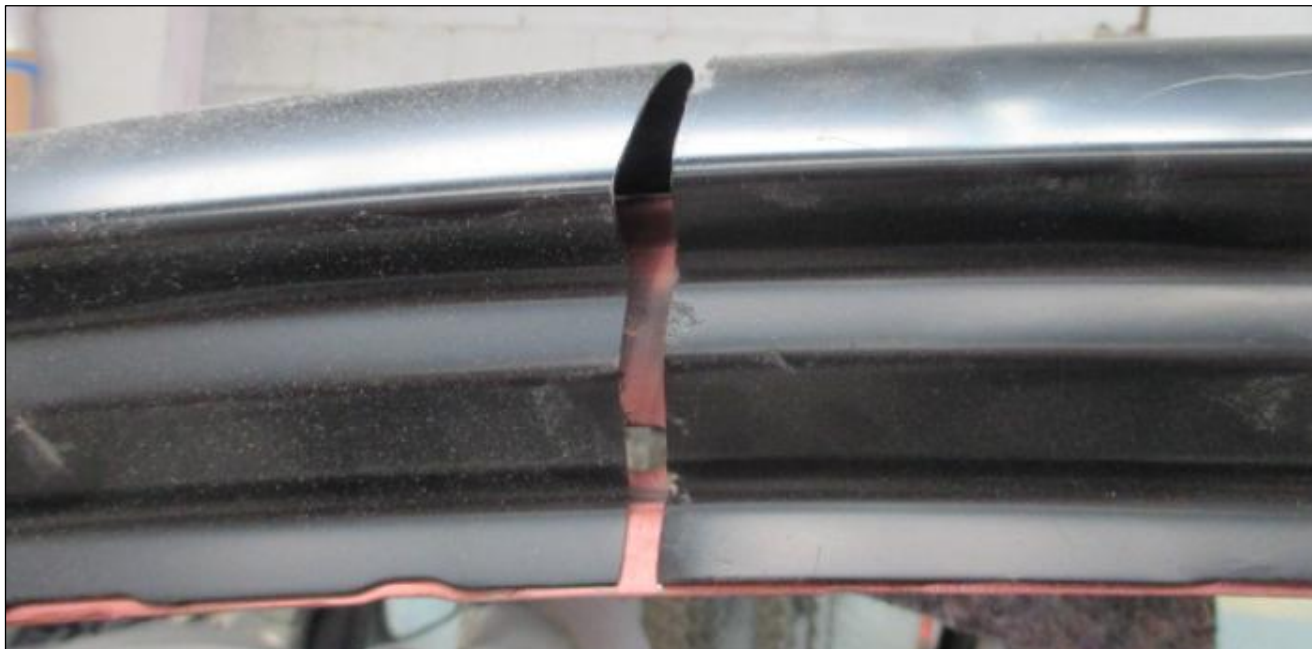
In instances where two or more new service panels need to be joined together in order to encompass all of the damage, the (pre-cut) cut locations of the individual replacement components often don't match up with each other, leaving gaps or spaces between joints that require additional (and often more complex) welding procedures to be performed (see *Image 25* on Page 16).

Image 25: When fitting two or more outer panels, the cut locations of the (pre-cut) supply parts often don't match up with each other.

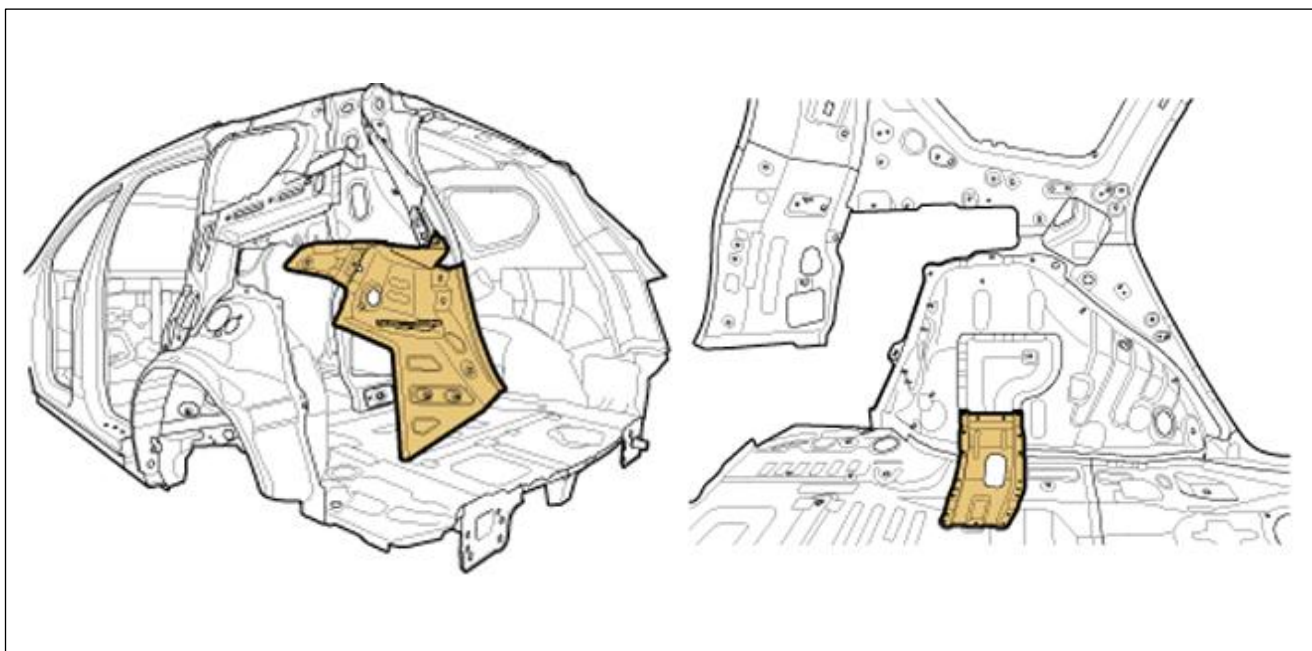
HMG replacement multi-panel sub-assembly service parts don't necessarily include all the welded components that are associated with (or make up) conventional sub-assembly structures (as would normally be expected).

In these instances, supplementary removal, installation and welding procedures will often need to be performed, as well as the procurement of additional replacement components (see *Image 33* below).

Image 33: In this example, the inner rear quarter multi-panel sub-assembly doesn't include the two components shown in yellow.
