Cut and Shut Repair Method

Clarification on the Cut and Shut Repair Method

Supporting New Zealand's Repair Certification Industry

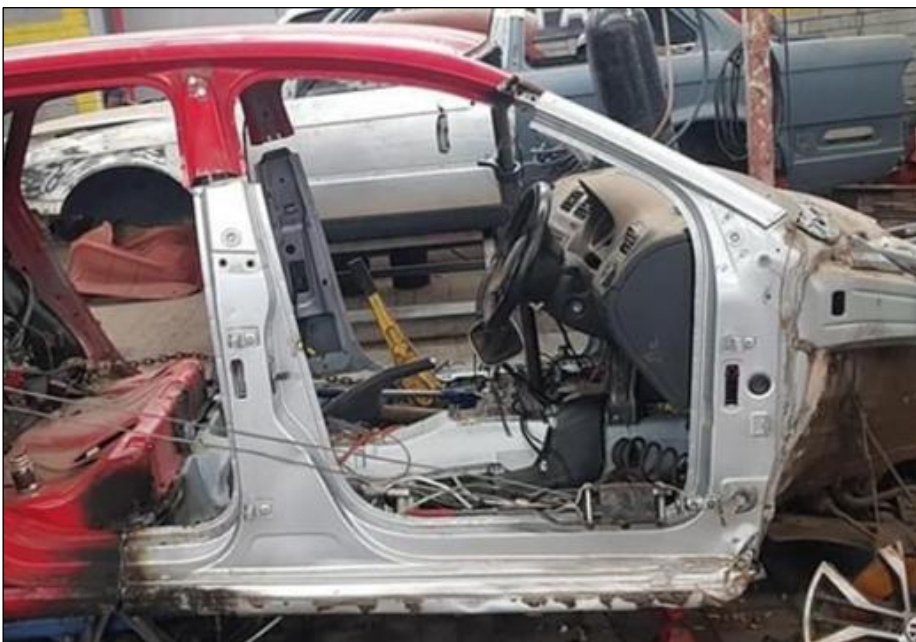
A corresponding second-hand replacement body section (from a salvaged vehicle), cut in the same positions, is subsequently welded in - essentially making one body structure from two vehicles (see *Image 1*).

Image 1: A cut and shut example - the major body sections of two vehicles are joined to make one body structure. Image credit ⁽¹⁾.

A cut and shut is a method of repair that involves linearly cutting away the entire rear or front body section (usually outside factory join locations) of a collision-damaged vehicle through both left and right inner and outer pillar structures, inner and outer sill/rocker structures, and across the floor pan (including any associated cross-members).

In simplest terms, a cut and shut is a repair method that effectively joins two predominant portions of a vehicle together, at (usually) other than the vehicle manufacturer’s factory join locations.

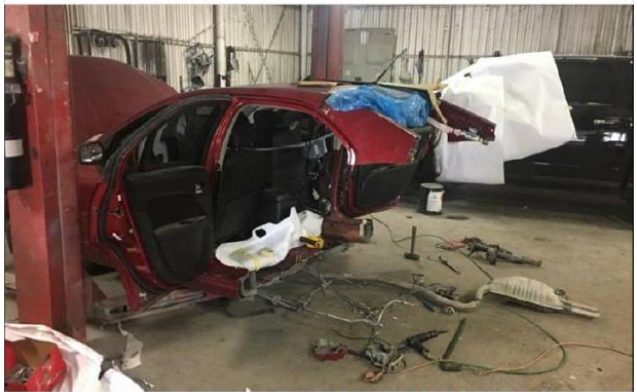
Full-body sectioning (clipping) is not a safe or viable repair option and should not be done, under any circumstances. Full-body sectioning will not result in a complete, safe, and quality repair.

In the collision repair industry, full-body sectioning, often referred to as clipping, is the process of joining large assemblies cut from separate vehicles. This involves cutting through multiple panel layers in a combination of A-, B-, C-, and D-pillars, the quarter panels, the rocker panels, and across the floor pan. The undamaged portions from these vehicles are then welded to complete the "repair." This type of procedure is done without supporting documentation from the vehicle maker.

Image 3: I-CAR RTS Portal article on full-body sectioning (2017). Click [here](#) to see the full article.

Installing large welded assemblies, such as full-front or full-rear body sections, involves making multiple joints in multiple structural panels and reinforcements. On all late model vehicles, the reinforcement panels in the vehicle side structure are made from high- and ultra-high-strength steels, aluminum, and carbon fiber that contribute to the structural integrity and occupant safety of the vehicle. Introducing a sectioning joint in any of these parts will adversely affect the performance of the vehicle structure during normal operation as well as during another collision.
