Motorcycle Brake Lever Safety Risk

Best-practice Guidance to Prevent Front Brake Drag Risk

About RepairCert NZ Technical Bulletins

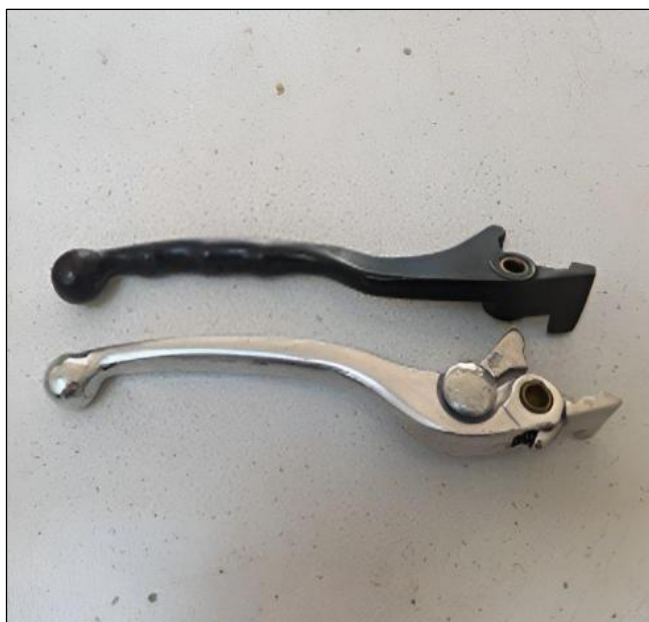
Image 1: Examples of aftermarket OE replica brake levers.

Aftermarket front brake levers are available in a wide variety of configurations (in addition to those that replicate the OE components - *see Image 1*), including span-adjustable, foldable, short, long, and adjustable lever length (*see Image 2*).

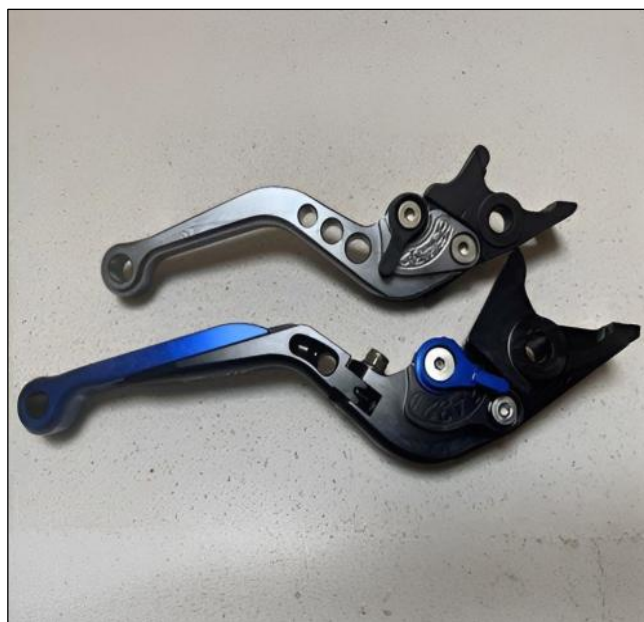
Image 2: Examples of adjustable aftermarket brake levers.

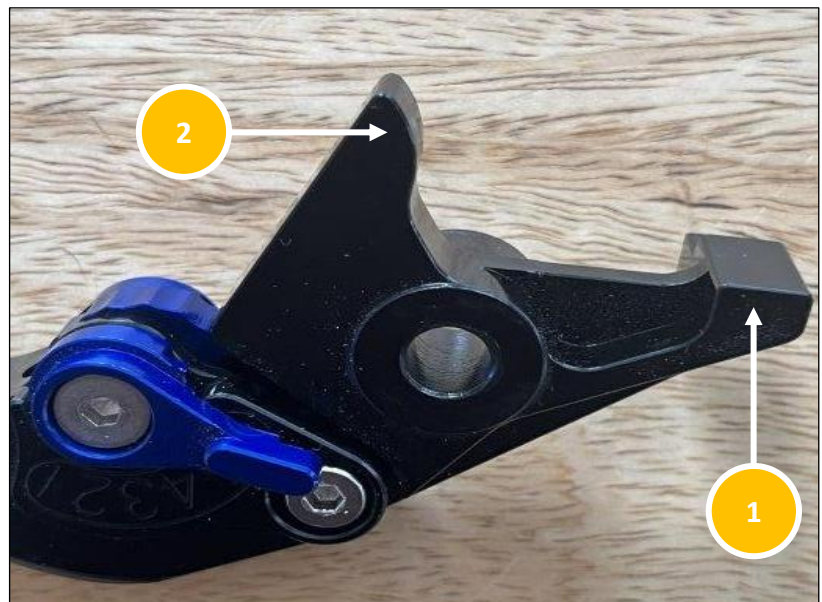
On some brake levers, the shape and profile of the brake lever return stop (marked as '1' in images 3 and 4) can prevent the lever from fully returning to its released position against the lever base perch.

This can inadvertently cause the brake actuation lever (marked as '2' in images 3 and 4) to create a pre-load against the brake master cylinder pushrod, potentially blocking (or partially blocking) the compensating port inside the master cylinder (see Image 5).

Image 4: Close-up of brake lever return stop (1), and brake actuation lever (2).

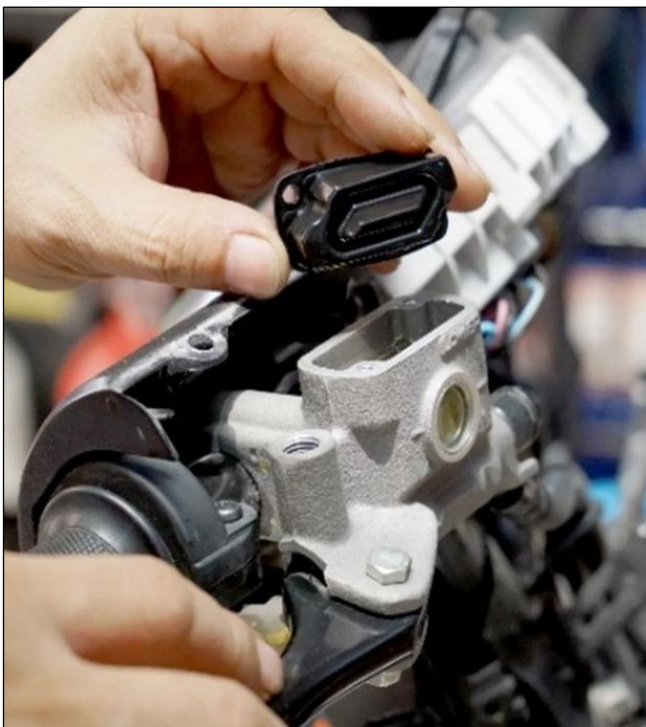
Image 6: Checking for a small fluid pulse inside the fluid reservoir.

- Remove the reservoir fluid cap, and with the brake lever applied, observe whether a small fluid pulse is visible in the fluid reservoir when the brake lever is subsequently released - this confirms that the compensating port is uncovered, and the piston is fully returning to its rest position (*see Image 6*).
- At the brake caliper(s), apply direct even pressure to the brake pads to push them away from the rotor - the brake pistons (behind the pads) should retract easily (*see Image 7 and Notes 3 and 4*). If the brake pads do not return smoothly under pressure, remove the brake lever and try pushing the pistons back again. If they move freely without the lever, this indicates that the brake lever may be poorly designed or defective.
- With the front of the motorcycle raised off the ground, check that the front wheel spins freely every time the front brake lever is applied and released.

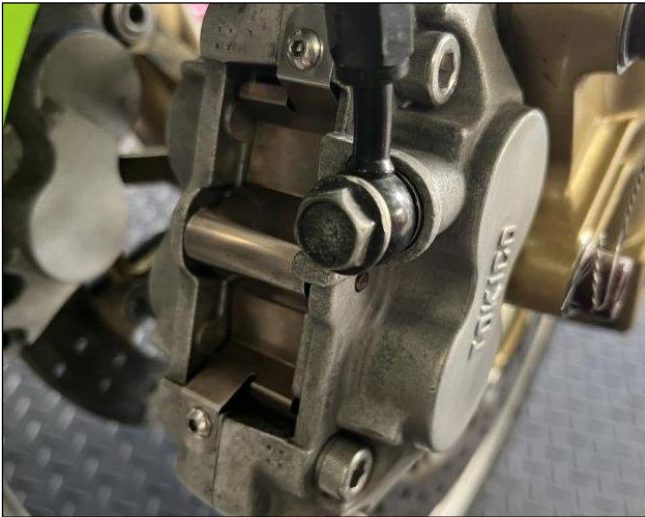
Image 8: Anti-rattle spring plate that typically requires removal.

Note 3	Accessing the brake pads will often first require the removal of the anti-rattle spring plate (<i>see Image 8</i>).
Note 4	Some brake caliper designs require removal of the brake calipers from the motorcycle to allow access to the brake pads (<i>see Image 9</i>).

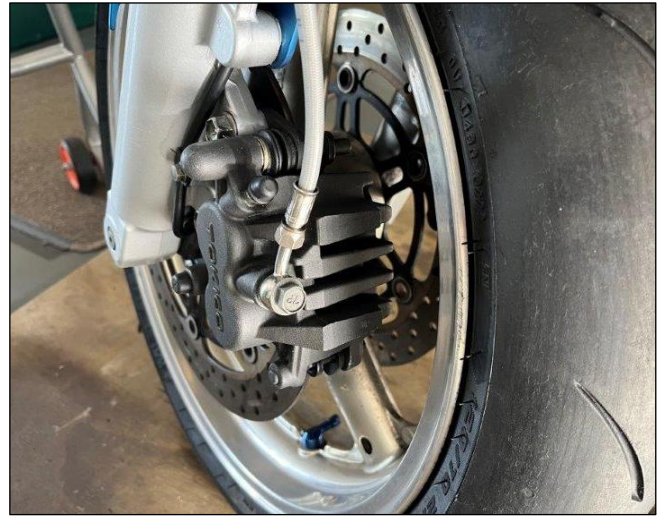
Image 9: Some caliper designs require removal to access the pads.

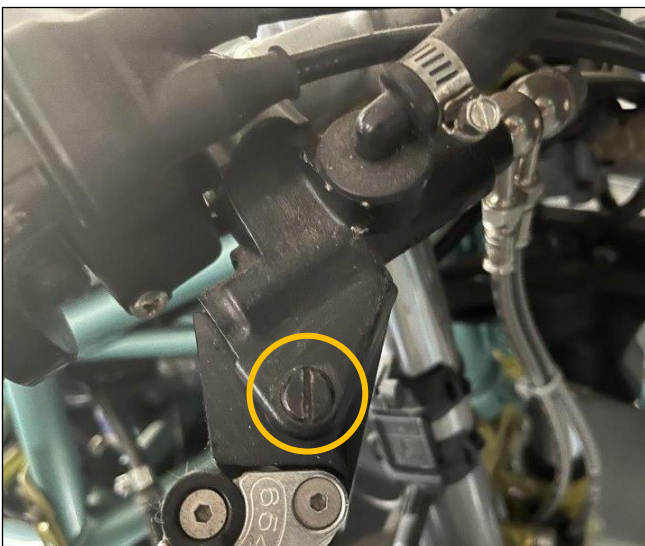
Image 10: Lever-to-perch pivot bolt/pin.

A Repair Certifier should also inspect the lever-to-perch pivot to ensure that (see Image 10):

- no binding or catching occurs on the pivot bolt/pin when the lever is pulled and released; and
- a threaded nut is securely tightened on the underside of the pivot bolt/pin; and
- the fasteners of all other adjustable pivot locations on adjustable lever sets (typically stainless machine screws with nylock nuts) are tight (see Note 5 and Image 11).

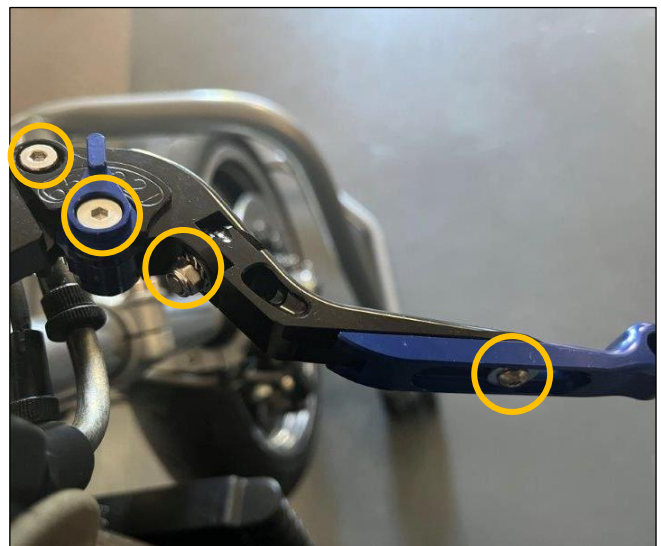
Image 11: Typical adjustable pivot fastener locations.

Note 5	Pivot fasteners on adjustable lever sets are prone to working loose over time - the application of a thread locking compound is strongly recommended.
--------	---
