REPAIRCERT NZ UPDATE

UPDATE No. 15 | 21/11/2022

Technical Support Group Gets the Ball Rolling!

Sectioning and Partial Replacement of Outer Panels

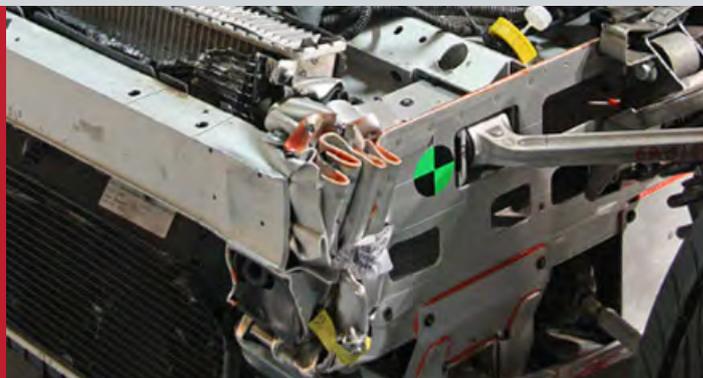
WARNING: Frame rail crush zones absorb crash energy during a collision and must be replaced if damaged. Prior to replacement of frame rail crush zones, straighten damaged frame rails to correct frame dimensions. Failure to follow these instructions may adversely affect frame rail crush zone performance which could result in serious personal injury to vehicle occupants in a crash.

Image above: Typical (albeit dramatic), example of a crush zone performing its intended function during an impact.
