Repairability of Outer Body Panels Are We Making the Right Decisions?

Supporting New Zealand's Repair Certification Industry

Purpose of this Technical Bulletin

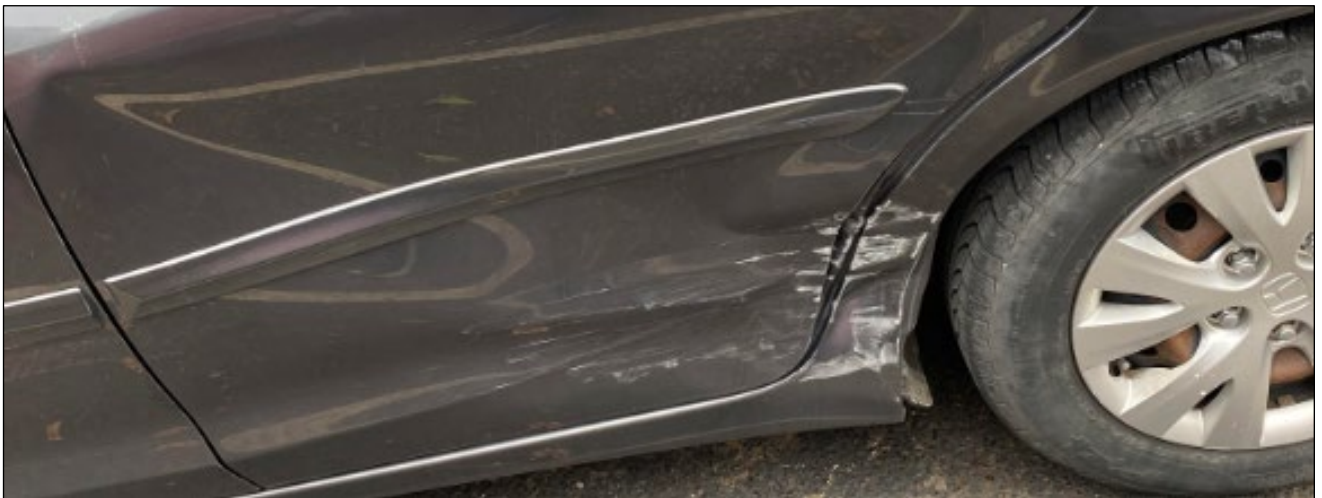
In Image 1, after the removal of body filler, it is obvious the base metal has been substantially thinned, with holes and perforations clearly visible. The extent of the damage determines that this panel should not be re-repaired, and replacement or sectioning is the appropriate 'repair' method (*see Image 1*).

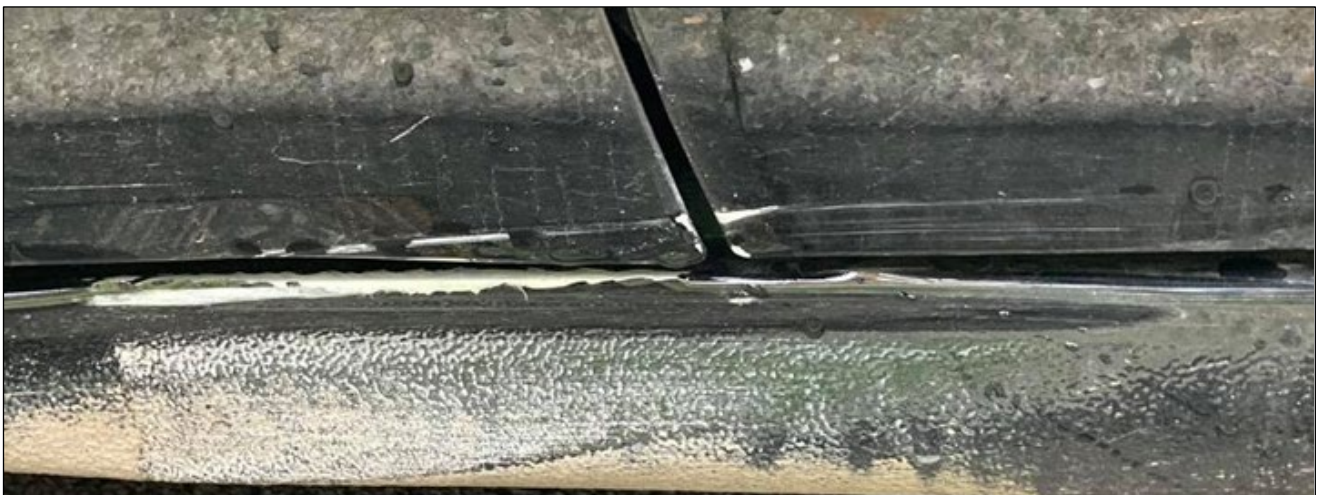
In Image 2, the steel has been over-stretched and work-hardened, and the original contours and shapes of the panel have not been restored. The extent of the damage determines that this panel should not be re-repaired, and replacement or sectioning is the appropriate 'repair' method (*see Image 2*).
