## Steering System Damage Analysis

### Correct Identification and Evaluation of Steering System Damage

Supporting New Zealand's Repair Certification Industry

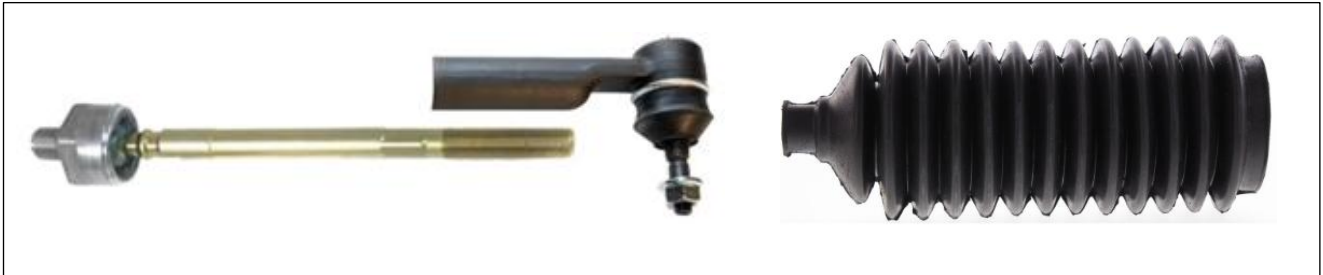
**Image 8:** Inner and outer tie rod end components.

On rack and pinion steering systems, the most common (and readily identified) components that are damaged in a collision are the inner and outer tie rod ends (and the protective rubber boots or 'bellows'). While these are typically available as individual components, they are often replaced together on collision-damaged vehicles (see Image 8).

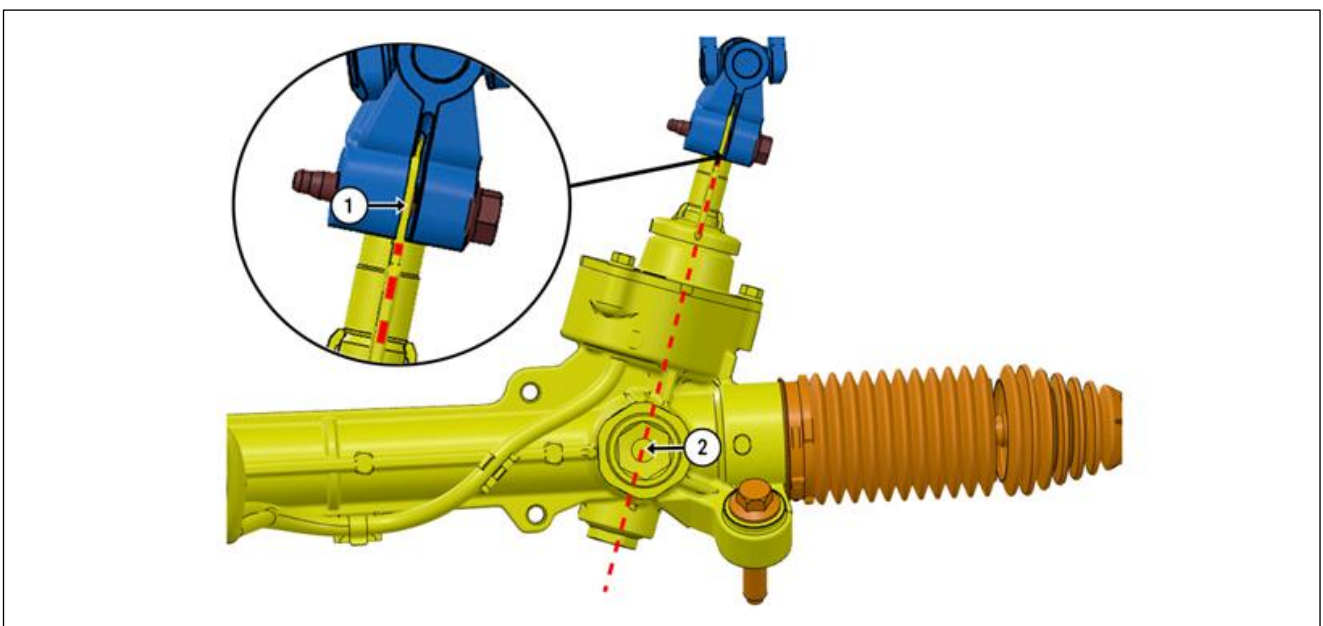
**Image 9:** Steering shaft to pinion alignment guide (excerpt from a Rivian service manual). Image credit <sup>(5)</sup>.

Correct alignment from the steering shaft through to the pinion is critical, as illustrated by the image below (see Image 9).

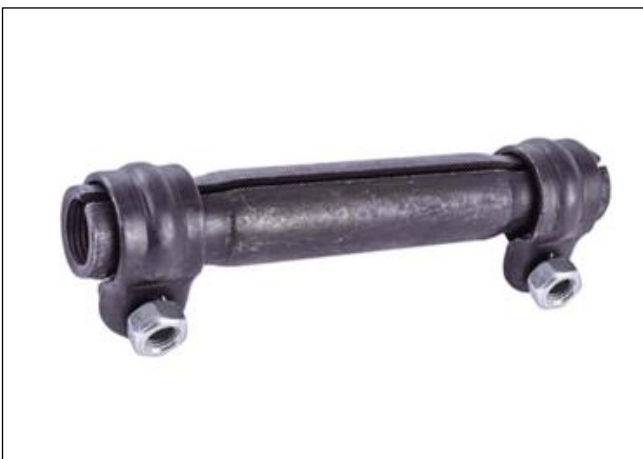
**Image 23:** Typical tie rod adjusting sleeve (with clamps).

Adjusting sleeves and clamps connect the inner and outer tie rod ends together, providing (a substantial range of) toe-in and toe-out adjustment. Being a hollow threaded sleeve (see Image 23), they are vulnerable to distortion from an impact which can make the sleeve out of round and cause damage to the internal threads.

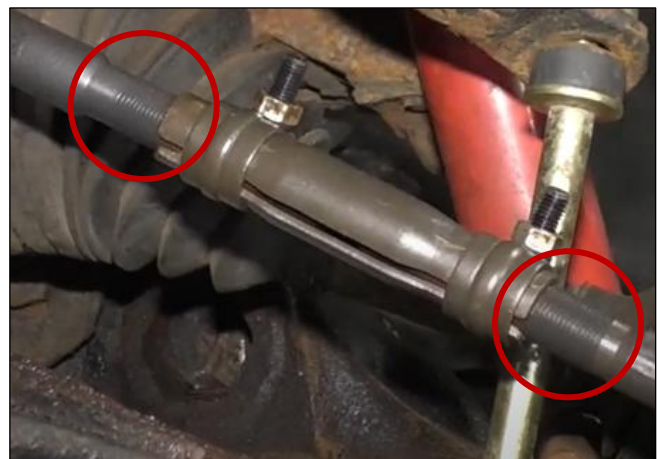
**Image 24:** Tie rod ends correctly installed into the adjusting sleeve (evenly adjusted and securely clamped). Note the correct positioning of the clamps on the adjusting sleeve.

While adjusting sleeves and the threaded portion of the tie rod ends provide for a wide range of toe-in and toe-out adjustment, after a wheel alignment has been completed, the adjustment measurements (amount of exposed thread visibly protruding out of the adjusting sleeves) should be even between the inner and outer tie rod ends, and consistent when comparing the left and right hand sides' assembled components. Importantly, the threaded portion of the tie rod ends should also extend deeply into the adjusting sleeves (see Image 24).

If it is observed that any of these adjustment parameters are inconsistent, it's likely that steering and/or suspension component damage or misalignment may still exist, or components have been installed (or reinstalled) incorrectly.

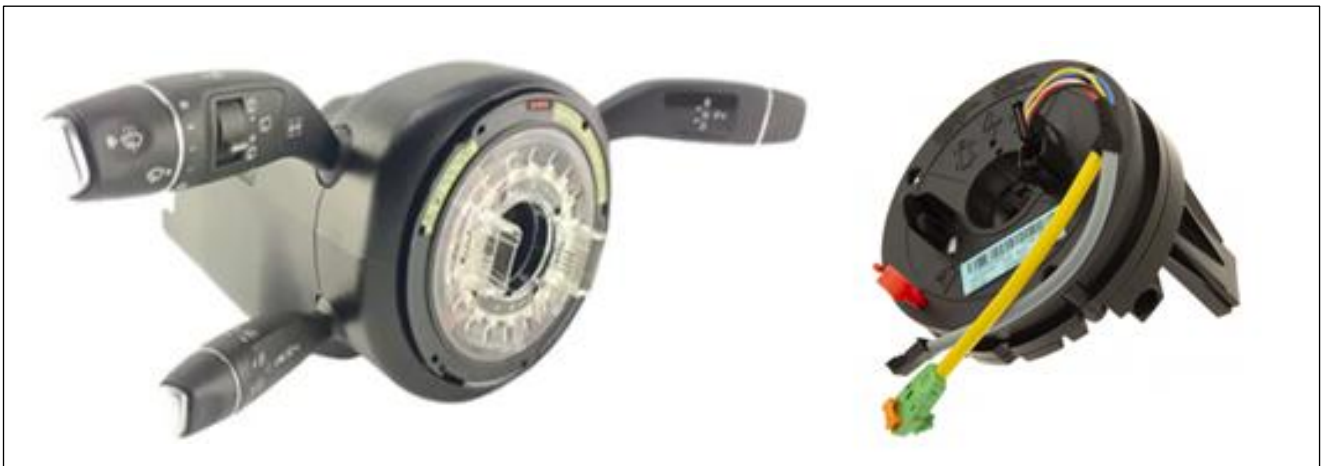
**Image 32:** Examples of steering angle sensors.

Dependent of the vehicle make, model, and year, the SAS can be integrated into the (SRS) clock spring and/or the multi-function switch (*see Image 32*).

Typically, any damage to the SAS is non-repairable, requiring the replacement of the component.
