Multi-panel Sub-assembly Replacement

Guidance on Replacing Multiple Inner and Outer Components as Sub-assemblies

About RepairCert NZ Technical Bulletins

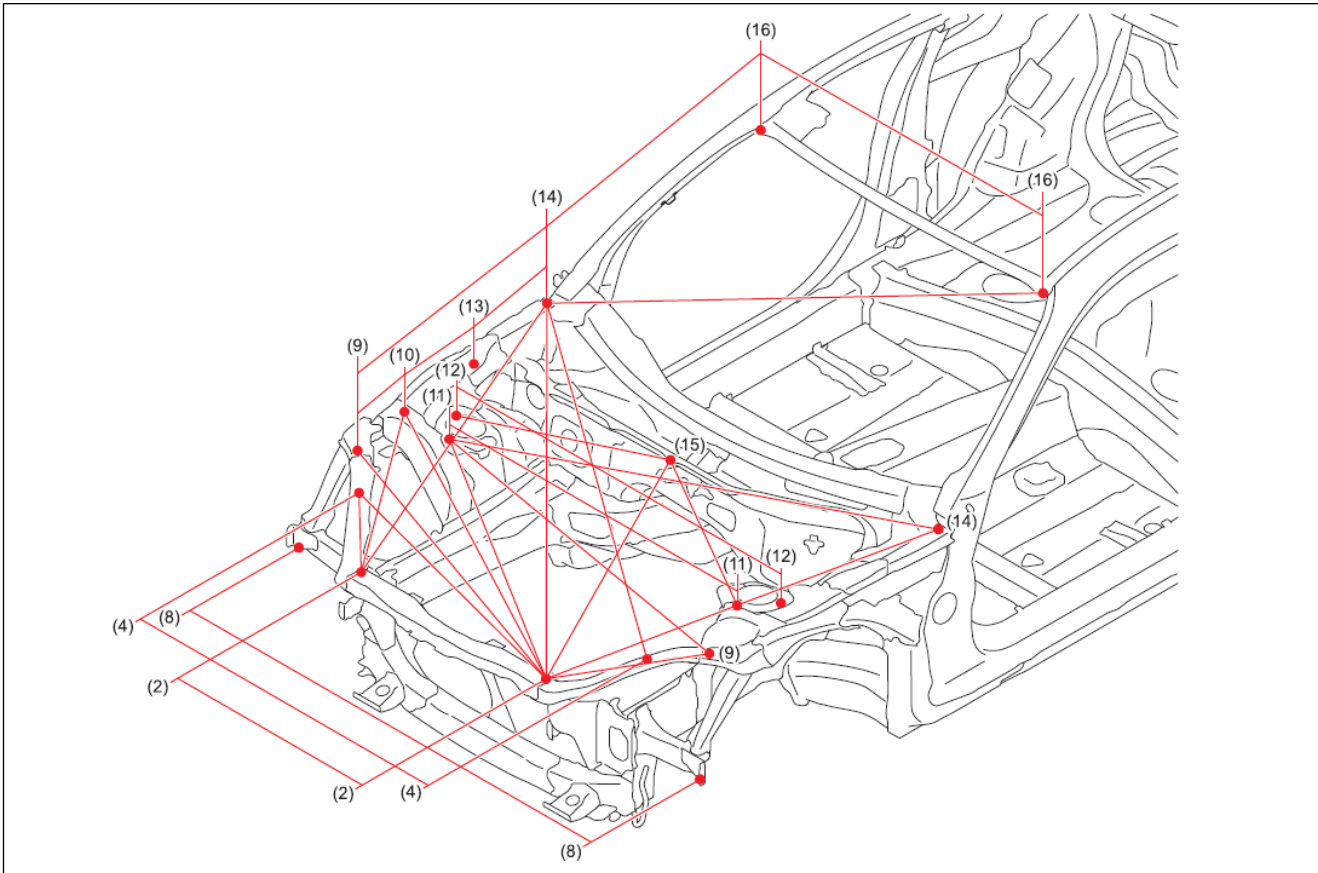
- less time needed to accurately align panels and associated components (see *Image 1* on Page 4), and
- on full body-side aperture replacements in particular, panel gap adjustment and door alignment procedures are simplified or eliminated altogether; and

Image 1: Less time is required to align panels and associated components.

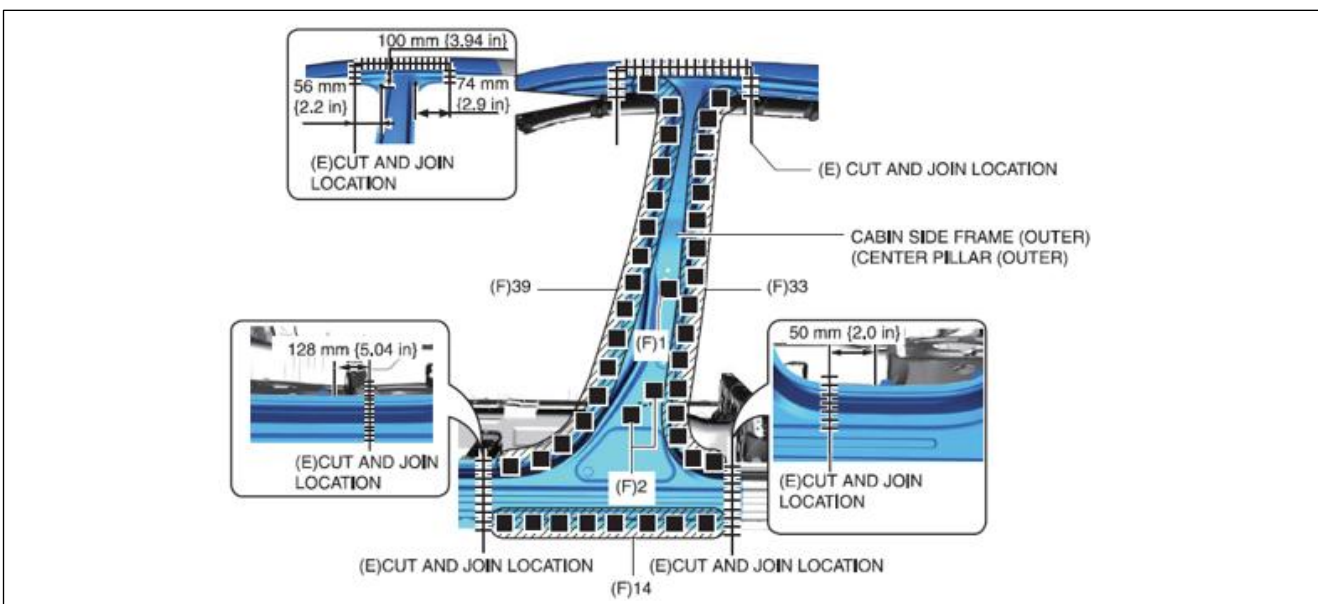
- outer panel(s) sectioning (cutting and joining at non-factory locations, including 'window cut-outs'), often required to gain access for the fitting and attachment of individual inner reinforcement elements, may not need to be performed at all (see *Image 2* on Page 4); and

Image 2: The sectioning (cut and join locations) of outer body panels, to access weld points of inner structures (as shown in this Mazda B-pillar procedure), may often not be required.

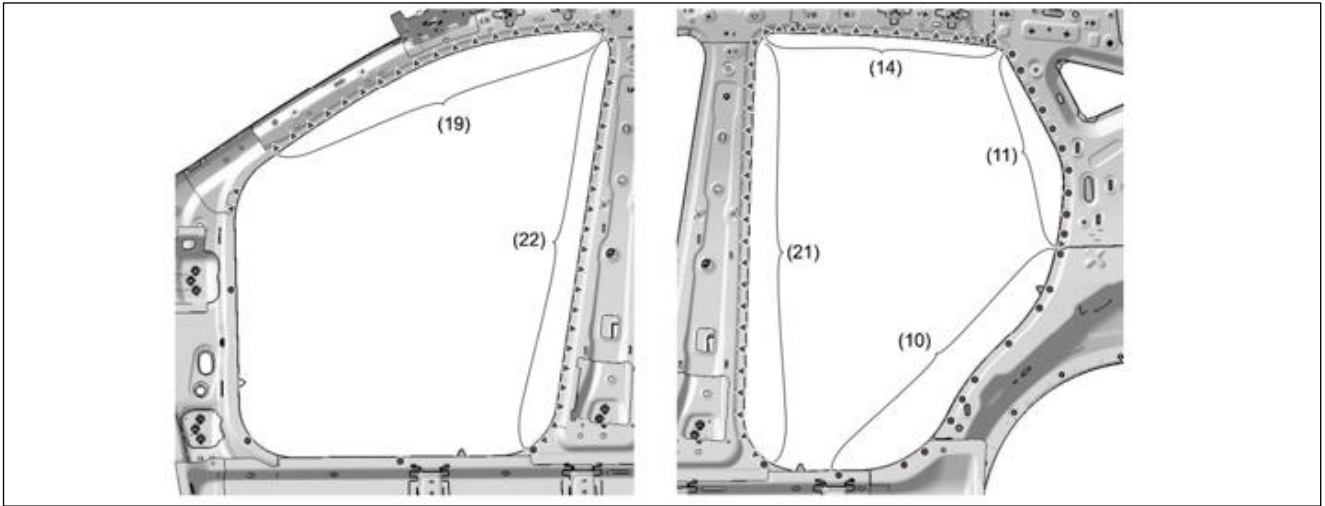
- retention of a substantial number of the original factory welds (see *Image 3* on Page 5); and
- a corresponding significant reduction in the number of replacement welds required; and

Image 3: A significant number of original spot-welds can be retained in many instances.

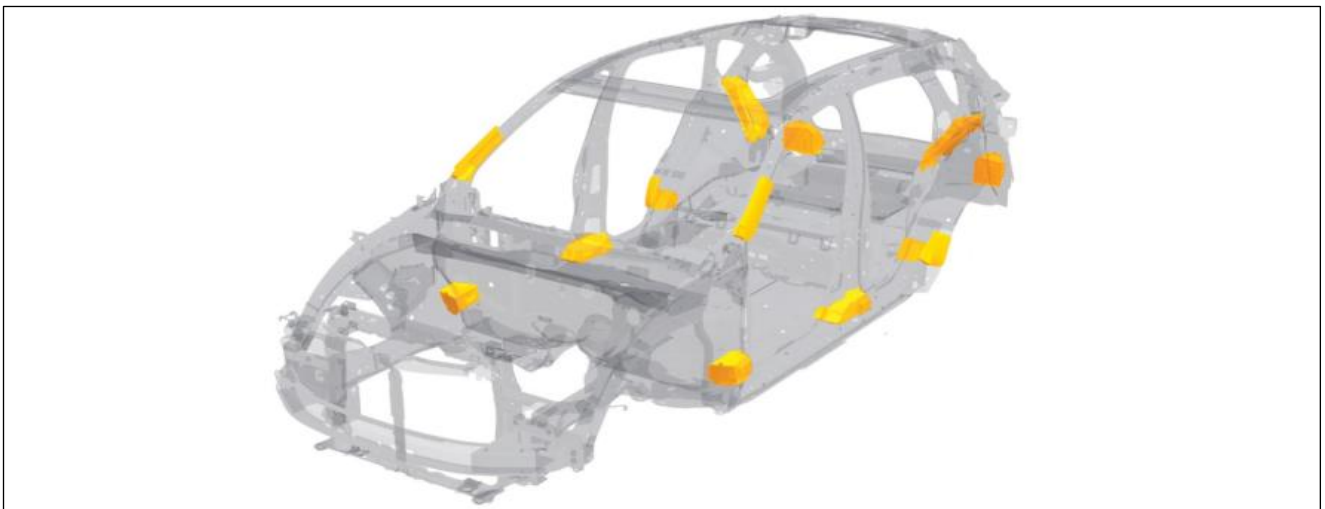
- that much of the vehicle manufacturer's original corrosion protection is retained; and
- depending on location and proximity to weld points, Noise Vibration Harshness (NVH) elements can often be left undisturbed (see *Image 4* on Page 5); and

Image 4: NVH elements can often be left undisturbed. Image credit ⁽¹⁾.

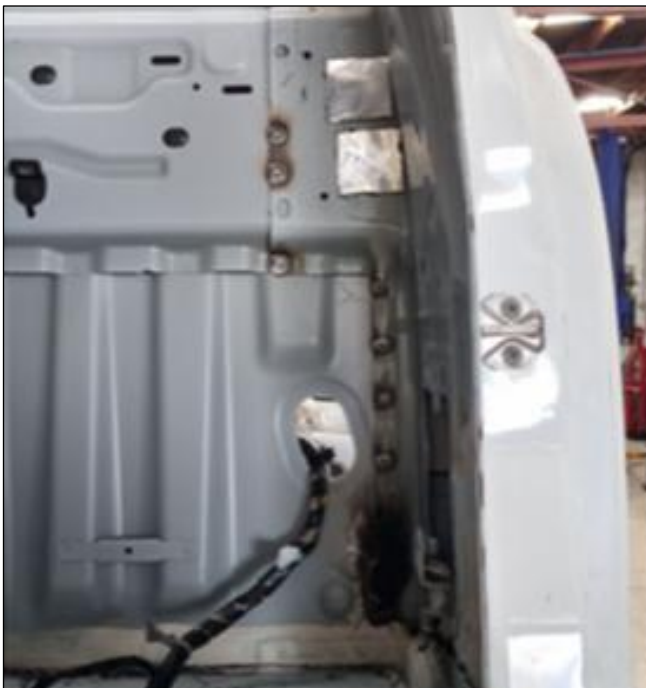
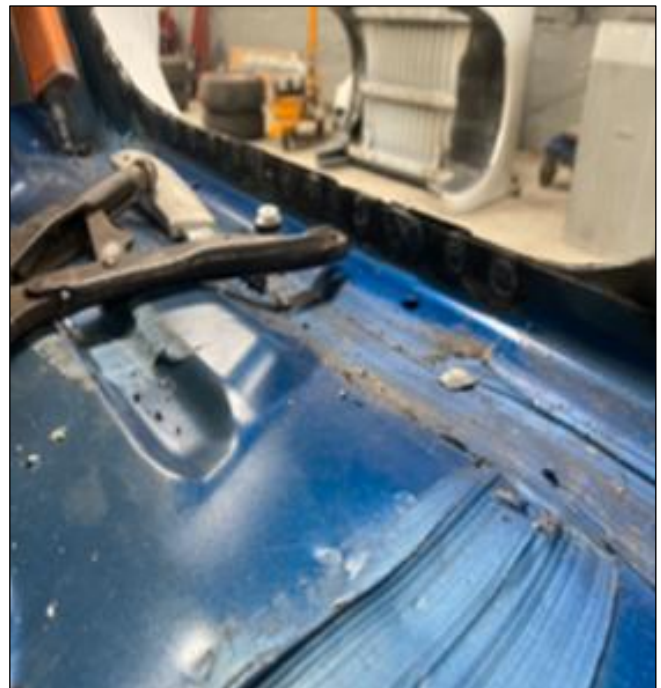
- because weld point attachment areas on the vehicle being repaired (where the replacement sub-assembly attaches) are predominately located on flange joints of inner structures which are hidden from view by sealing materials, floor coverings etc., a reduced need to 'dress' welds that would otherwise be required in locations where replacement welds are visible (see *Images 5 and 6* on Page 5); and

Images 5 and 6: Many of the required weld points are in concealed locations (behind trims, floor coverings, and insulation, etc.) and covered by sealing materials, underseal, or texture coats.

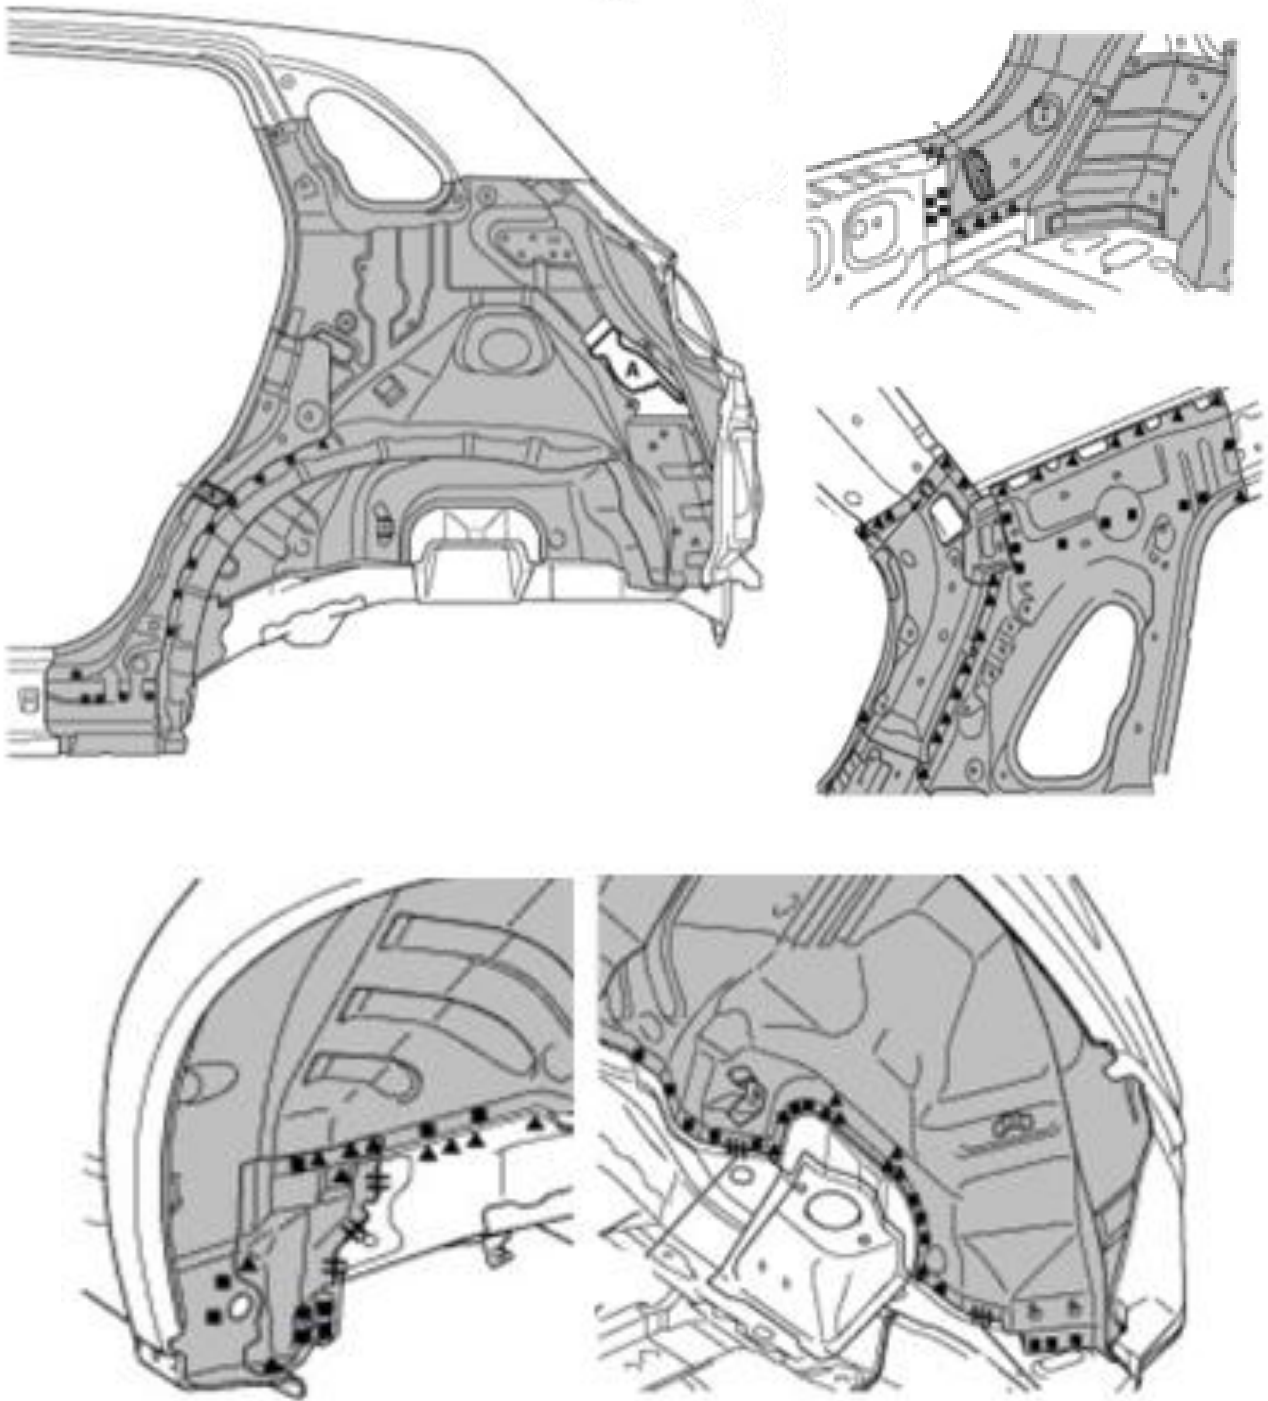
where spot-welders can't reach) replicates the replacement welding method recommended by most vehicle manufacturers in these locations (see *Image 7* on Page 6); and

Image 7: In this Mitsubishi inner rear quarter replacement procedure example, the predominant welding method specified is GMA-MIG/MAG welding.

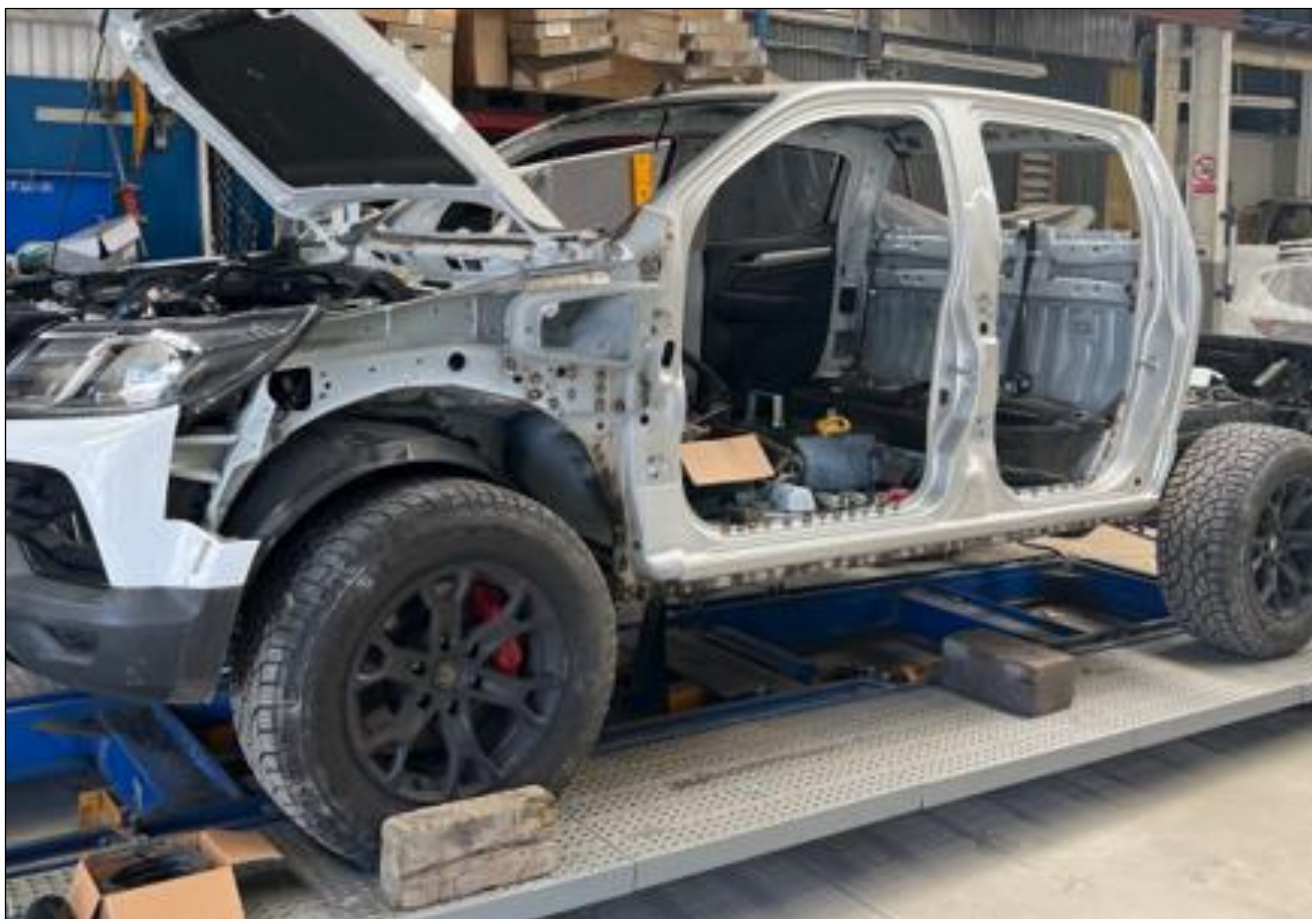
In this example, a complete inner and outer body-side aperture (including the roof structure [still attached]) has been installed (see *Image 12* on Page 9).

Image 12: The complete inner and outer body-side aperture sub-assembly (including the roof) is replaced.

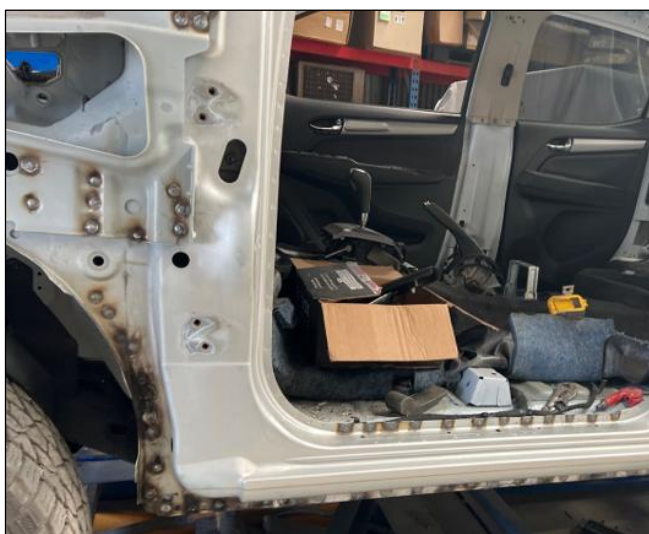
Image 13: Weld point detail - A-pillar and sill.

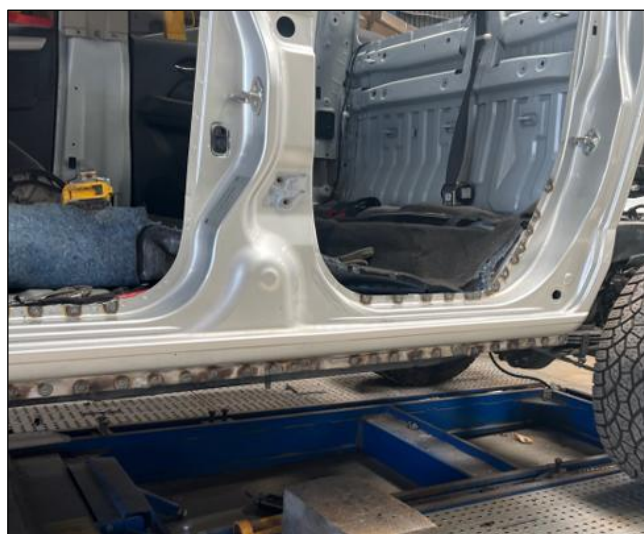
Image 14: Weld point detail - sill and C-pillar.

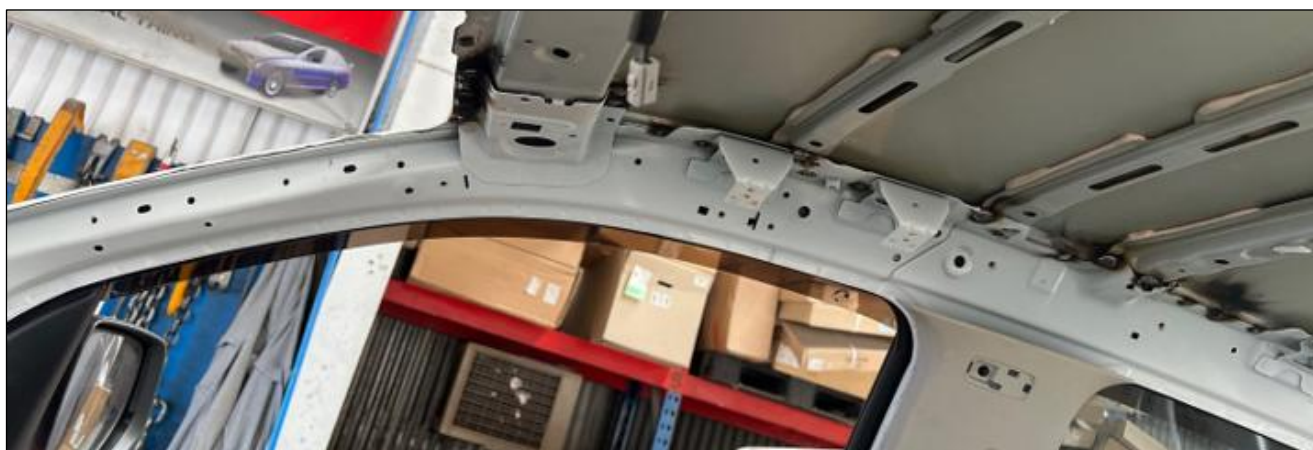
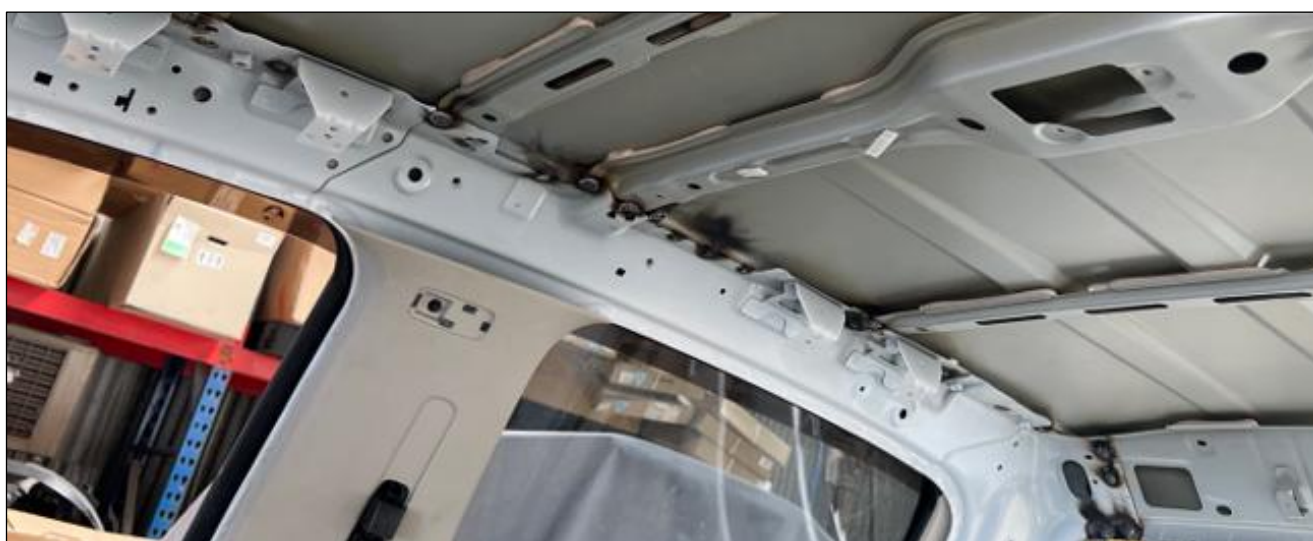
Images 15 and 16: Weld point detail – roof structure to existing inner cant rail and body-side structure.

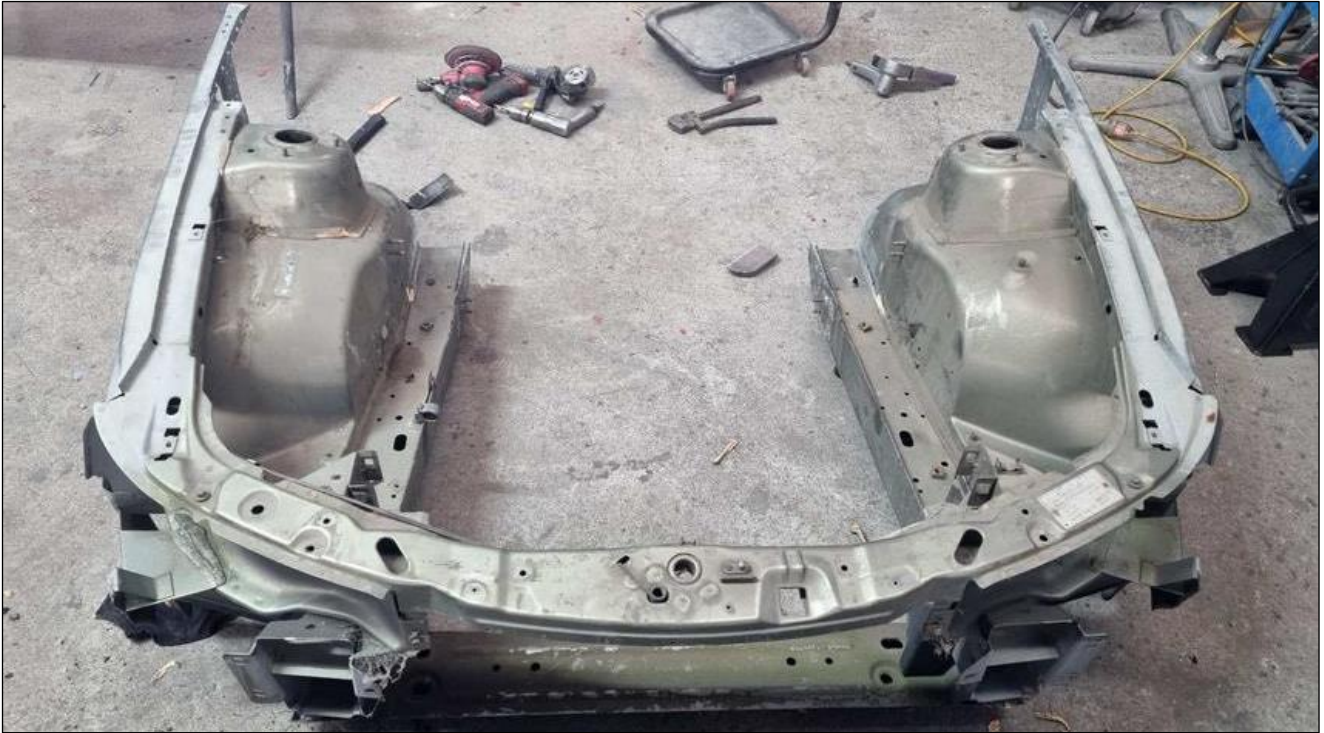
In this example, the entire front compartment structure, made up of both chassis rails and inner guards, the front cross-member, and radiator support were replaced (see *Image 17* on Page 11). With the extent of the original damage requiring the replacement or repair of multiple individual components, replacing the entire front compartment in this way was entirely appropriate, with benefits including:

Image 17: Complete front compartment sub-assembly.

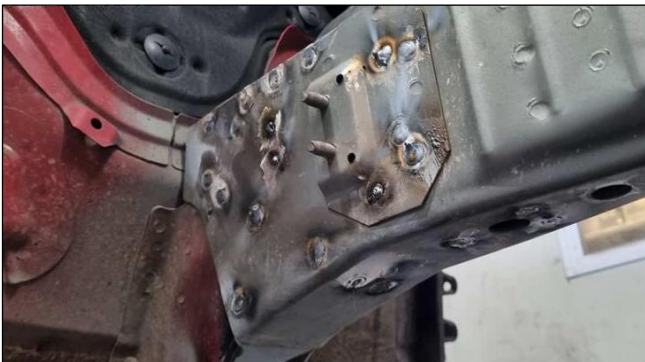
Image 18: Chassis rail to floor-pan rail weld points.

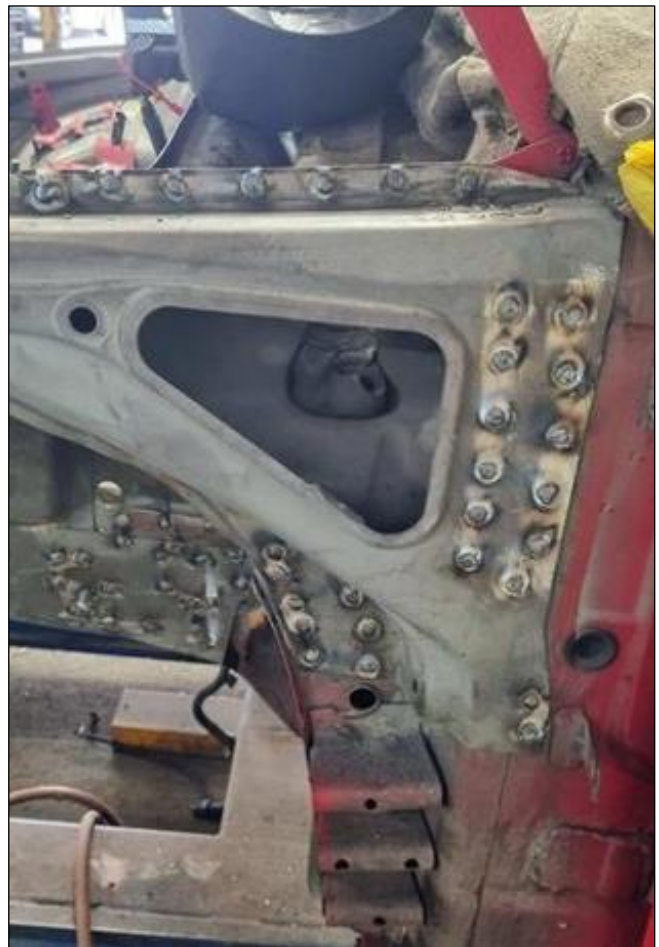
Image 20: Upper inner guard reinforcement to A-pillar weld points.

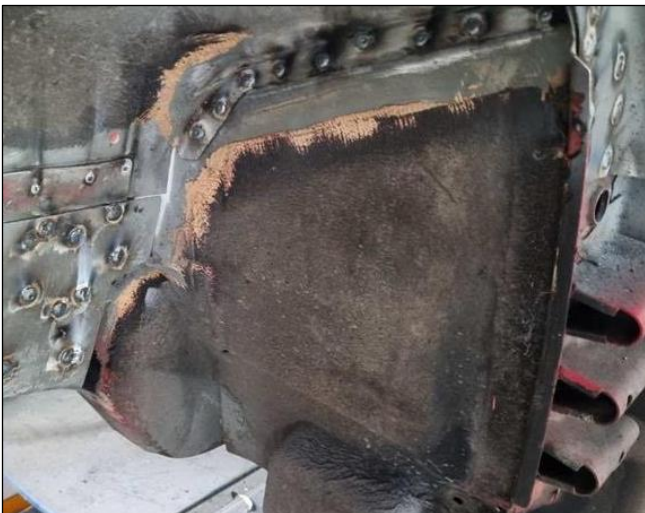
Image 19: Inner guard apron to bulkhead/firewall weld points.

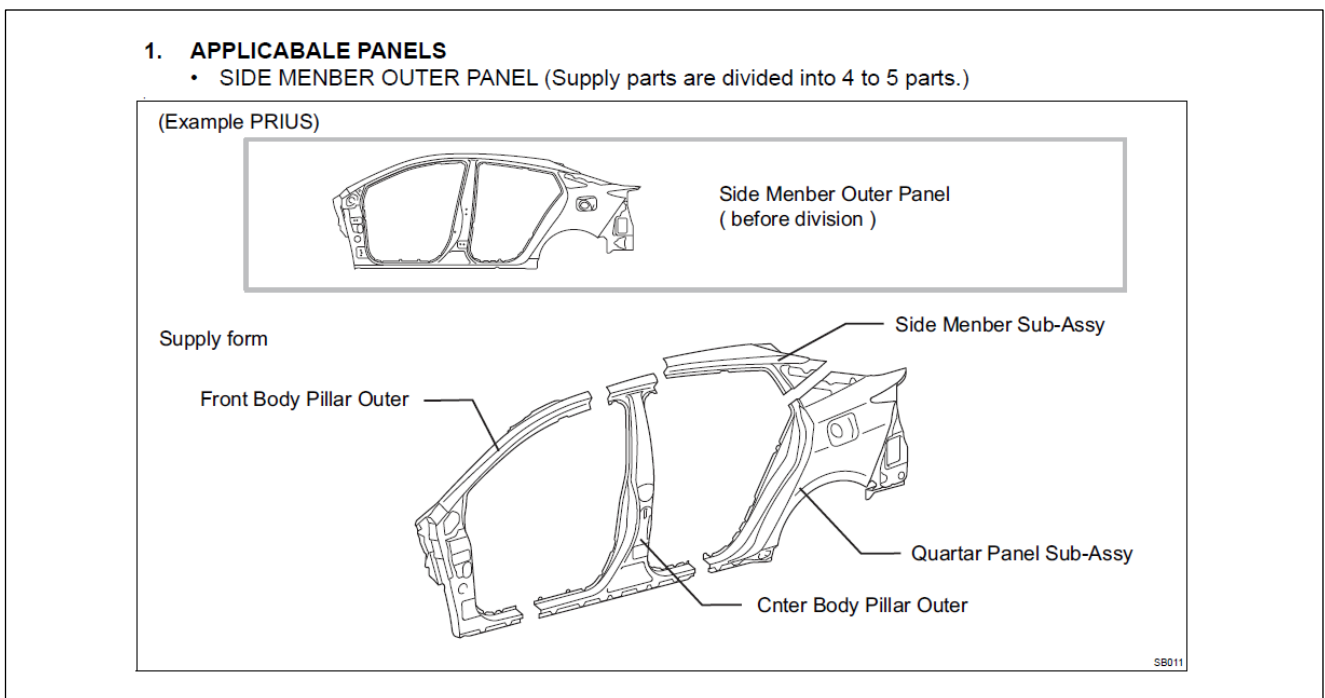
- In particular, new outer body-side (aperture) panels, are often not available as one-piece stampings (as used in production). For example, Toyota/Lexus only supplies the outer body-side panel pre-cut and divided into four or five sections and described as 'supply parts' (see *Image 24* on Page 15 and *Note 8* on Page 16).

Image 24: Excerpt from the Toyota's 'Partial Repair of the Outer Panels (Cut & Join Repair of Outer Panels)' Technical Bulletin.

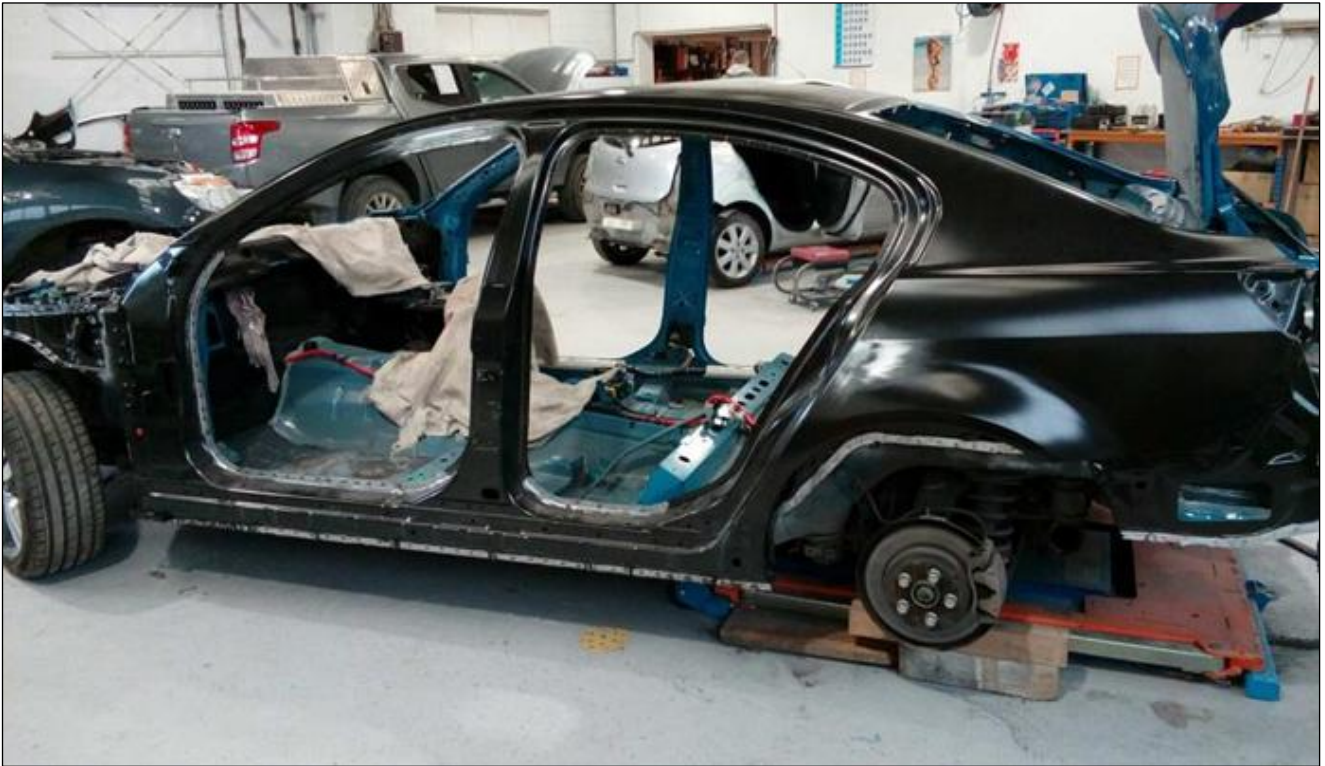
For VE and VF Commodore models, in addition to GM Holden supplying (or previously supplying) many individual body-side inner and outer components, including the A-pillar, B-pillar, sill/rocker, and inner and outer rear quarter panels (and corresponding BRM replacement procedures), they also supply the inner and outer body-side as a complete, pre-welded, multi-panel sub-assembly (see *Image 26* on Page 17).

Image 26: The complete (installed) multi-panel body-side sub-assembly on a VF Commodore sedan.

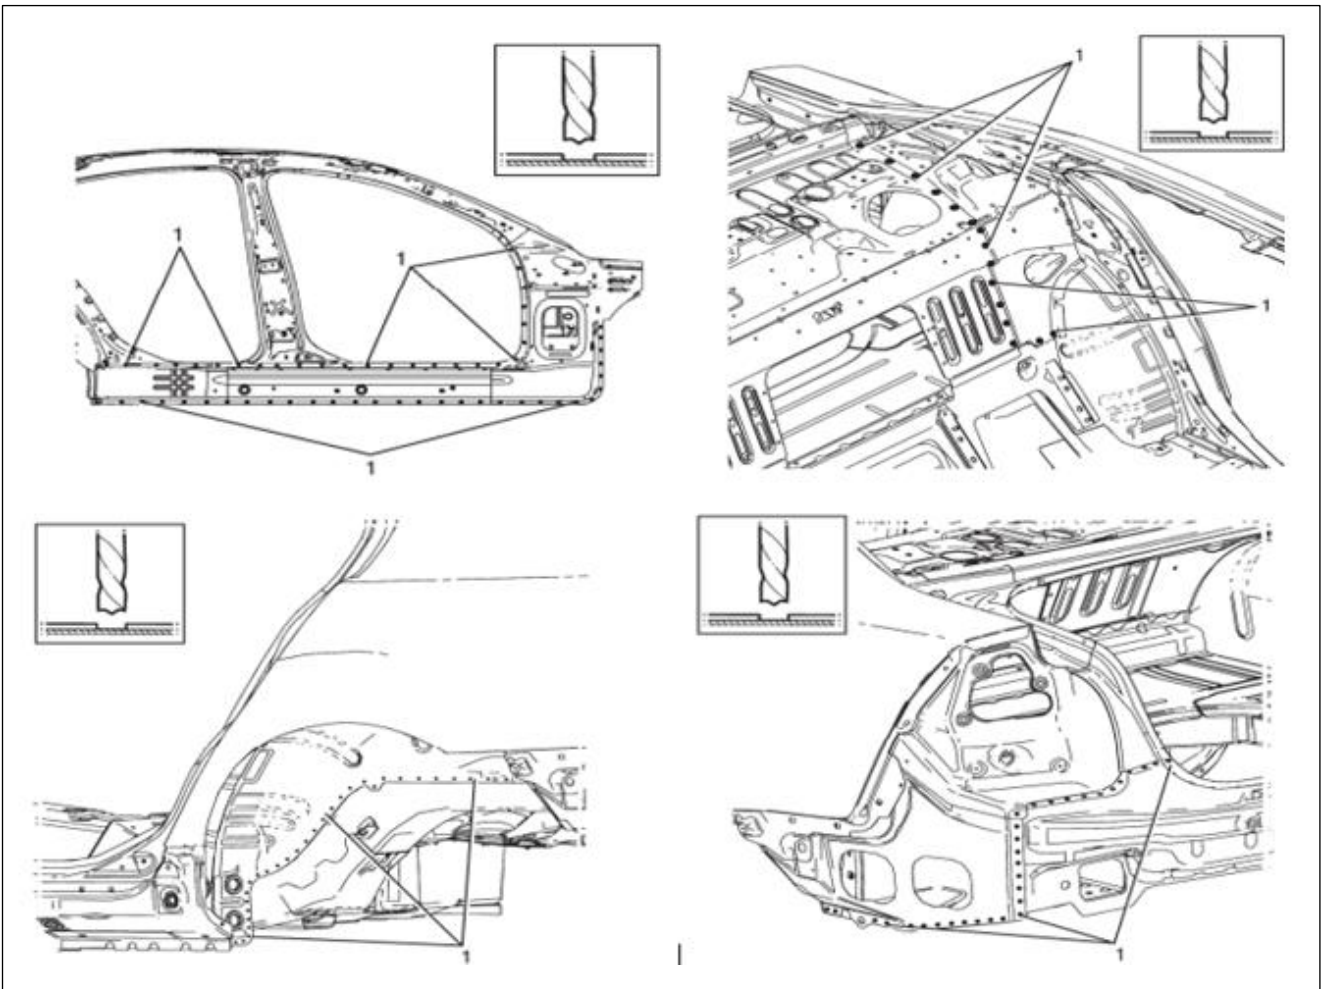
The multi-panel sub-assembly includes the entire outer (one-piece) body-side panel, inner rear quarter components, rear wheelhouse, inner cant rail structure, and all reinforcement components. The BRM for both models also includes comprehensive replacement procedures information under the description heading 'Side Door Opening Frame Replacement' (see *Image 27* on Page 17 and *Note 9* on Page 18).

Image 27: Excerpts from the GM Holden BRM procedure 'Side Door Opening Frame Replacement'.

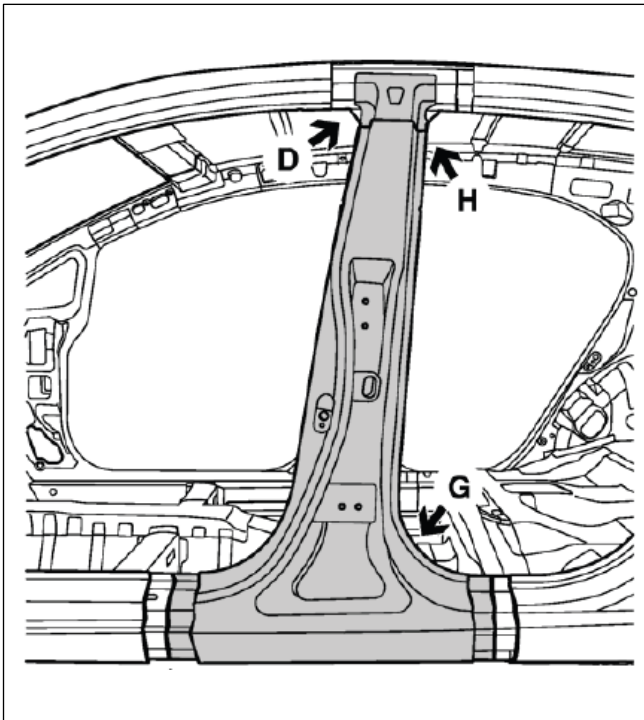
In conjunction with the information specified in the applicable BRM replacement procedure, the 'service condition' of many A-pillar, B-pillar (see *Image 34* on Page 20), and door ring (see *Note 10* on Page 20) multi-panel replacement sub-assemblies will most likely dictate that a combination of different joining methods (over and above conventional GMA-MIG/MAG plug welding and STRSW processes) are required (see *Image 35* on Page 20).

Image 34: Typical 'service condition' of a B-pillar multi-panel sub-assembly.

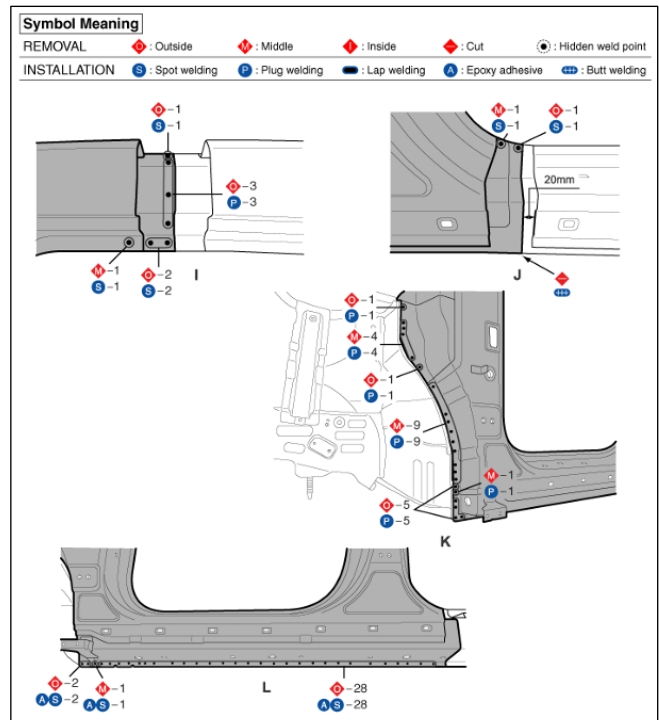
Image 35: Multiple joining methods are typically required.
